# Sample Inspection Summary Report

Prepared by Thoroughbred Property Inspections LLC

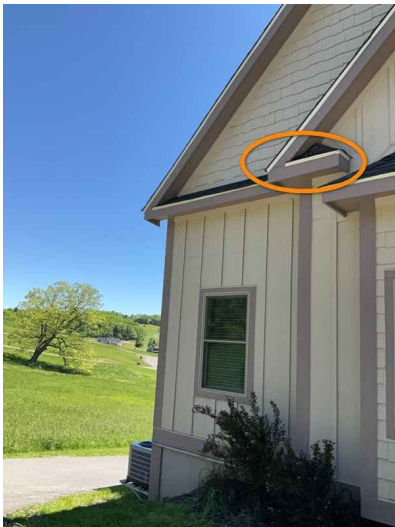
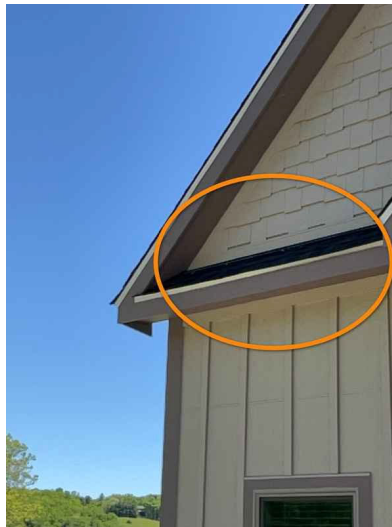
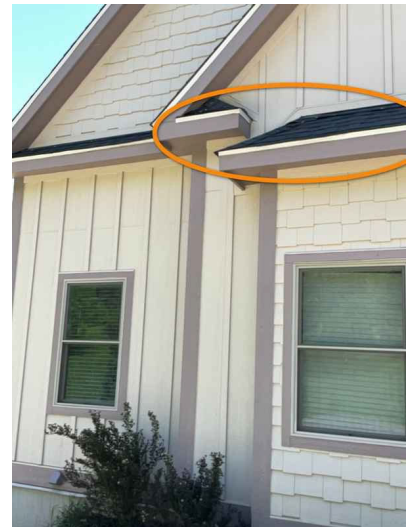
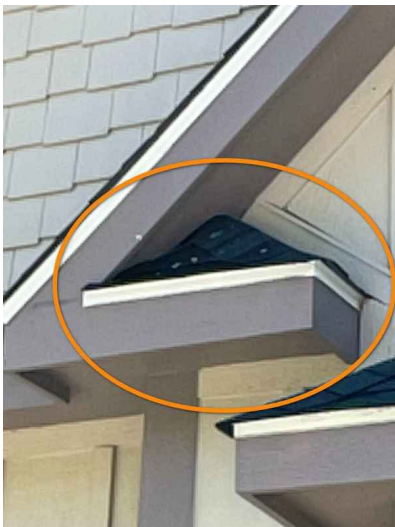
#### DECORATIVE GABLE PROJECTIONS

Open gaps were observed at the decorative gable projections where the roof meets the wall (roof-to-wall intersection), at the front of the home. These gaps create a potential pathway for water to enter behind the siding and trim. Over time this can lead to concealed moisture damage, wood rot, and interior staining.

Recommend evaluation and repair by a licensed roofing or siding contractor to properly flash and seal these areas within the next 6 to 12 months.

**Recommendation:** Contact a qualified roofing professional.

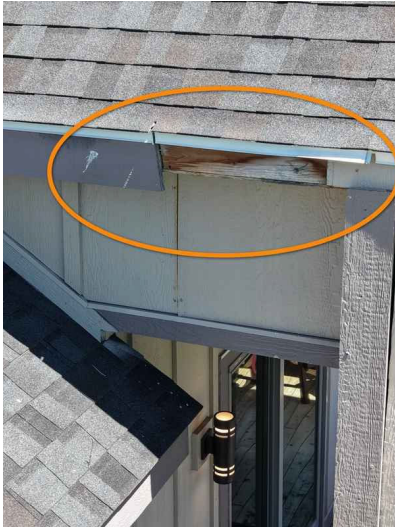
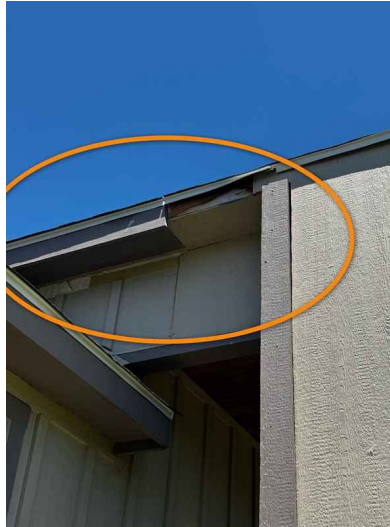
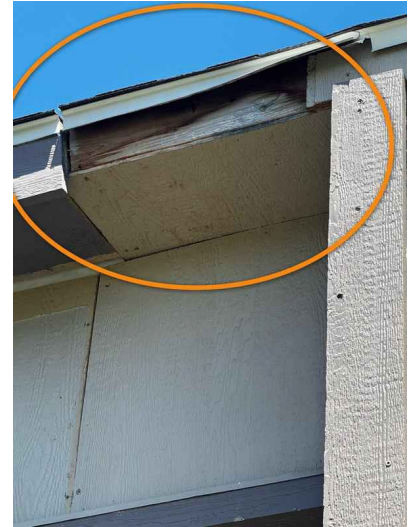
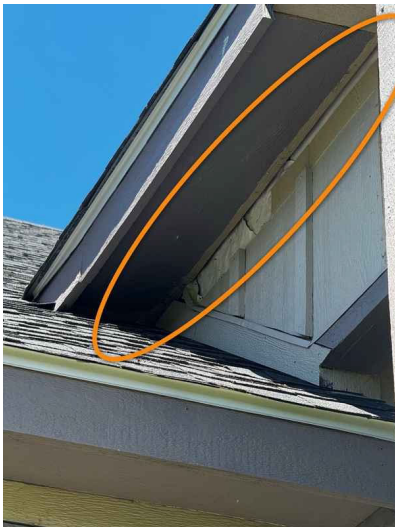
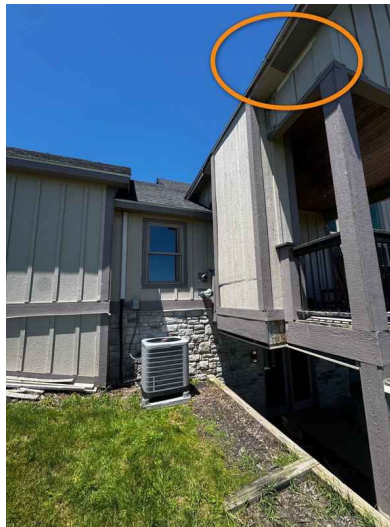
## MISSING SIDING/TRIM

The siding and trim behind the outdoor fireplace is missing siding and trim. These gaps create a potential pathway for water to enter behind the siding and trim. Over time this can lead to concealed moisture damage, wood rot, and interior staining.

**Recommendation:** Contact a qualified siding specialist immediately.

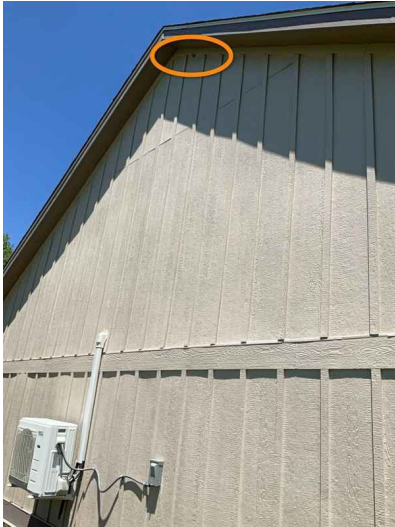
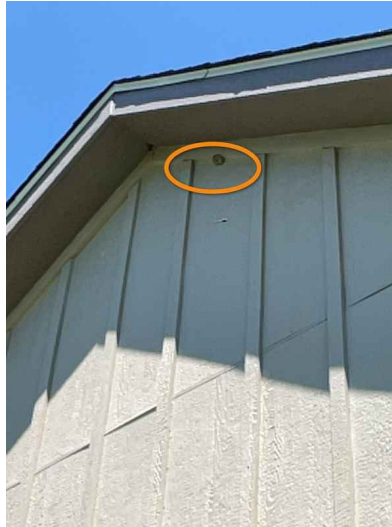
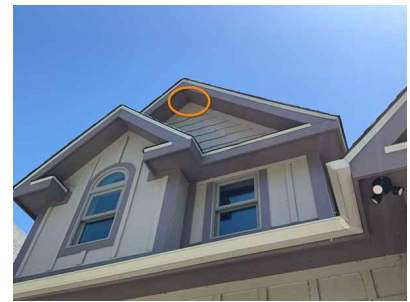
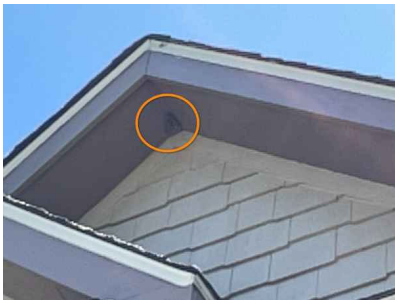
#### WASP/HORNET NEST

- Wasp/Hornet Activity - wasp or hornet nests were observed at exterior roof peaks. Removal by a qualified pest-control professional is recommended.

Wasp/hornet nests were observed at the front left peak and right-side peak. This presents a stinging hazard, particularly to anyone with allergies.

**Recommendation:** Recommend removal by a qualified pest control professional.

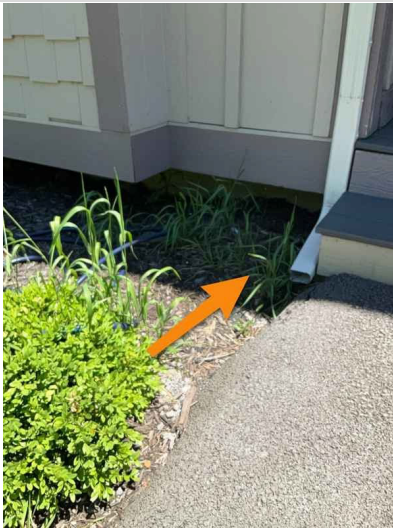
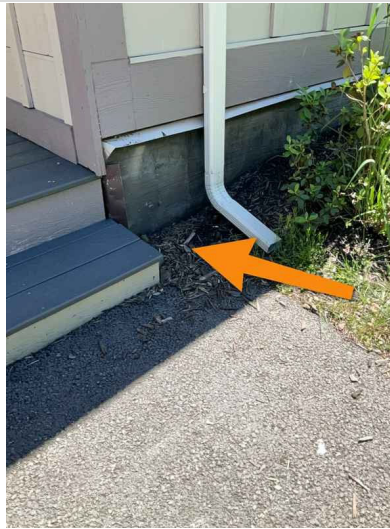
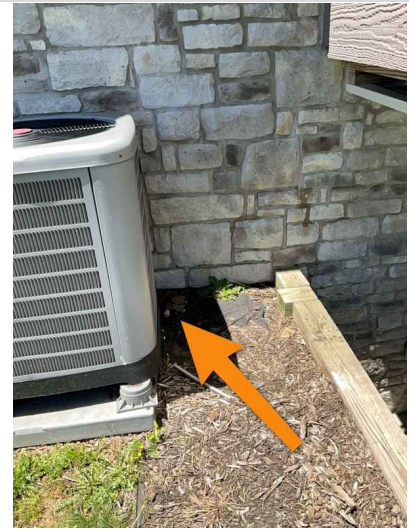
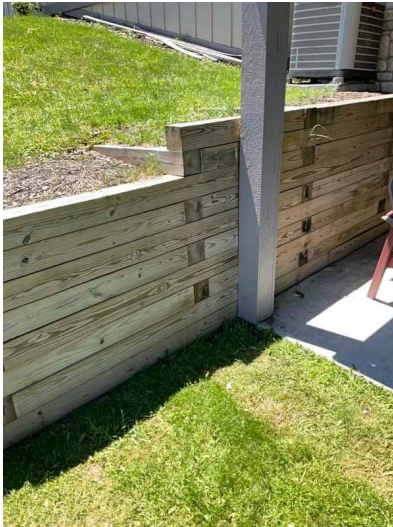
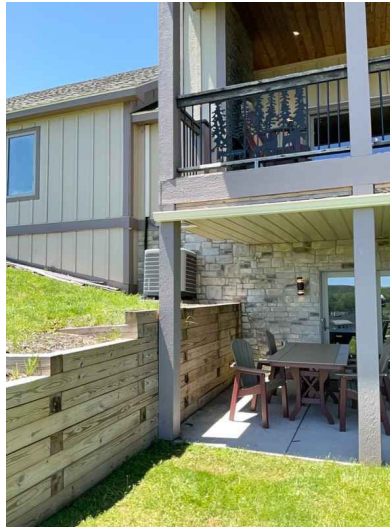
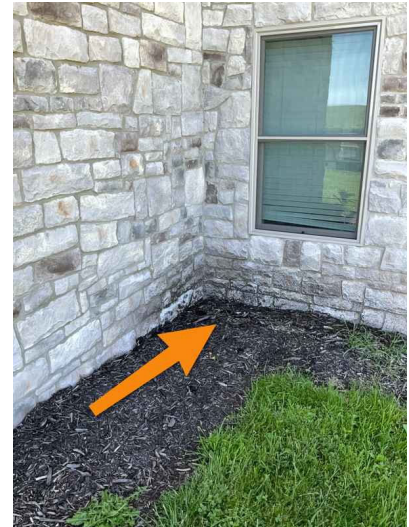
#### NEGATIVE GRADING

Grading is sloping toward the home in some areas. This could lead to water intrusion and foundation issues.

**Recommendation:** Recommend a qualified landscaper or foundation contractor regrade the affected areas so water flows away from the home.

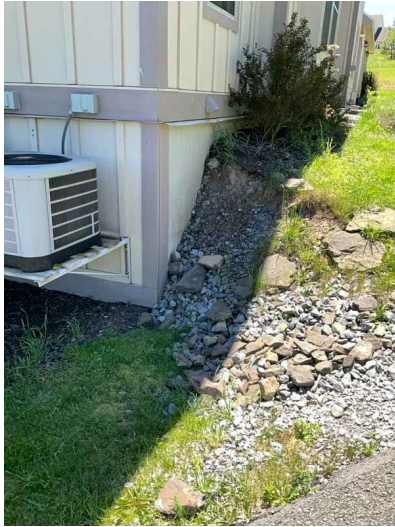
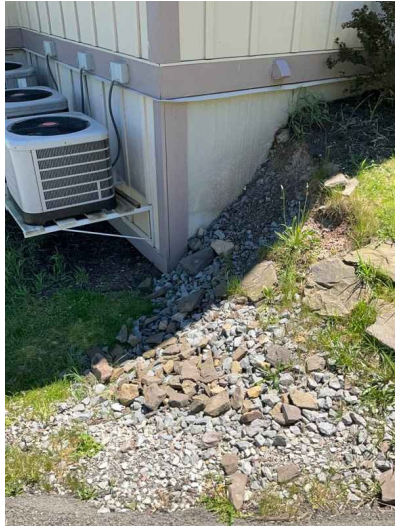
### EROSION

Localized soil erosion was observed along the foundation at the front, left corner. Erosion of this type can undermine soil-bearing support and allow water to reach the foundation and crawlspace.

**Recommendation:** Recommend evaluation and correction by a qualified grading/drainage contractor.

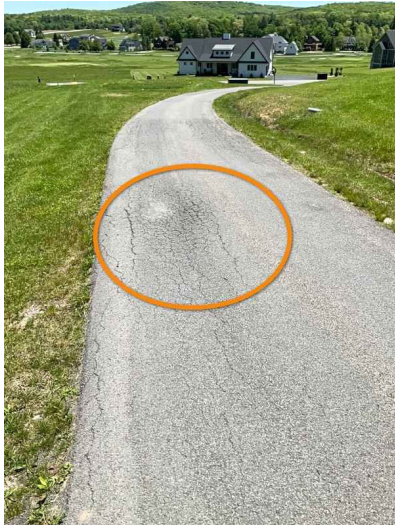
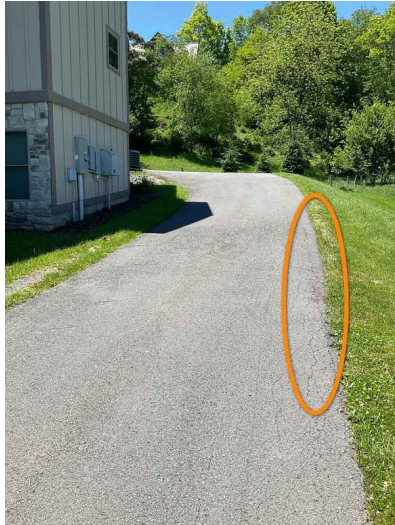
##### DRIVEWAY CRACKING - MINOR

Minor cosmetic cracks were observed, which may indicate movement in the soil.

**Recommendation:** Recommend monitoring and patching/sealing as needed by a driveway contractor.

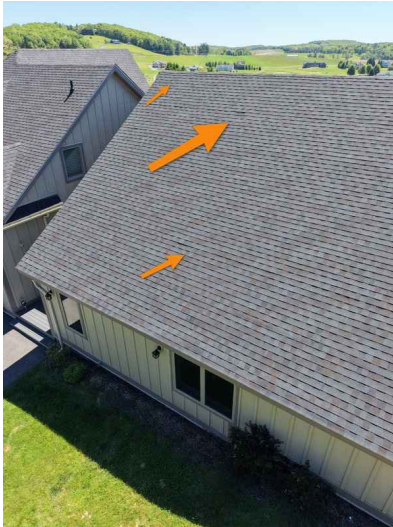
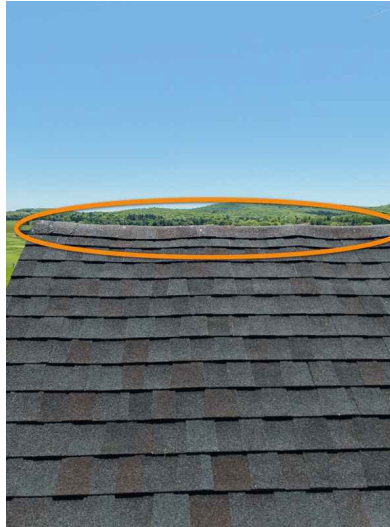
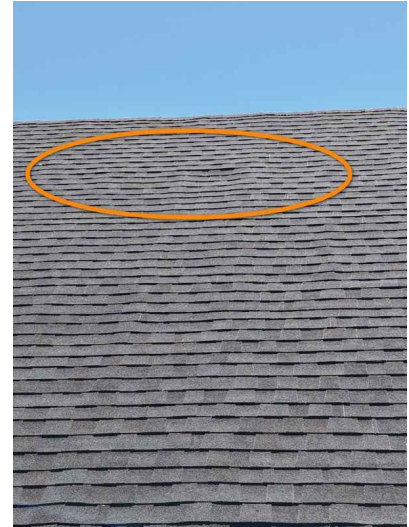
##### POOL ROOF SAGGING

- Pool Room Roof Deformation - the roof covering above the pool room exhibits noticeable waviness and ridge-cap displacement. Because the pool room is a high-humidity environment, these conditions may indicate moisture-related deterioration within the roof assembly. Further evaluation by a qualified roofing contractor experienced with pool-room assemblies is recommended.

The roof covering over the pool room exhibits noticeable waviness/undulation in the roof plane, and the ridge cap shingles

are lifting in several locations. In a high-humidity pool environment, deformation of this type is frequently associated with moisture within the roof assembly (for example, condensation on the underside of the roof sheathing) and/or installation deficiencies, though the cause could not be confirmed without further evaluation.

The interior of this room has metal wall and ceiling finishes, which do not display the staining typically associated with concealed moisture. Therefore, the absence of visible interior water staining should not be interpreted as the absence of moisture intrusion or concealed damage. This is a significant condition.

**Recommendation:** Recommend immediate evaluation and repair by a licensed roofing contractor experienced with roof assemblies over high-humidity/pool spaces, including assessment of the roof deck, attic/assembly ventilation, and moisture conditions.

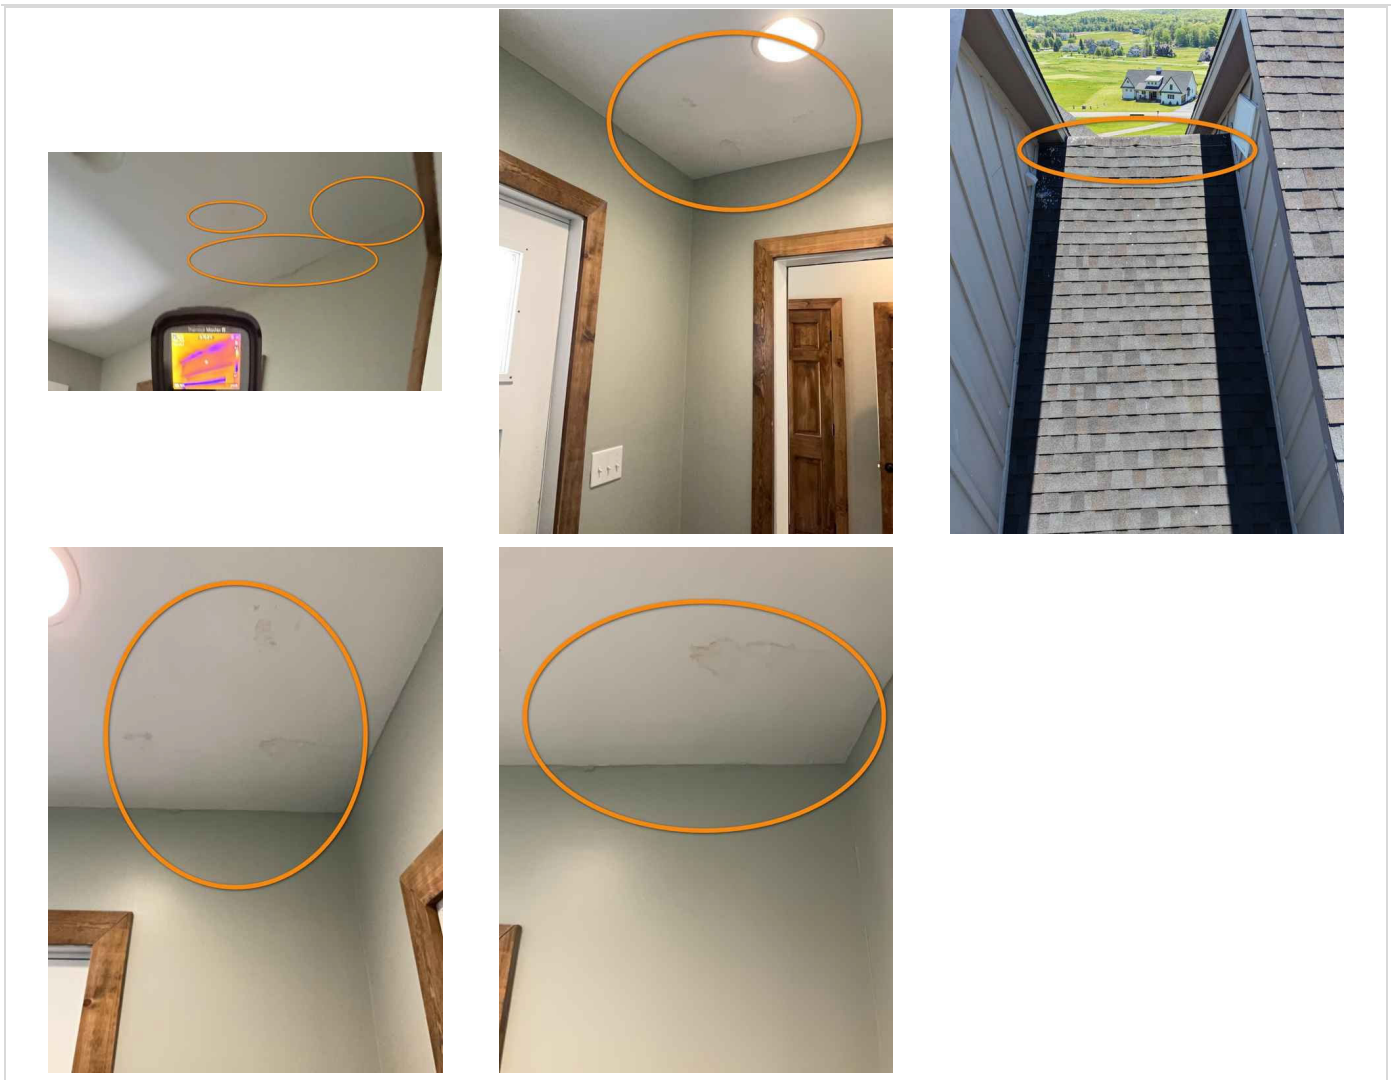
#### ROOF OVER ENTRY WAY - PROBABLE LEAK

- Probable Roof Leakage at Roof Transition - evidence consistent with water intrusion was observed at the roof transition between the pool room and the main structure. Continued leakage could contribute to concealed deterioration, mold growth, and structural damage if not corrected.

Probable water intrusion was observed at the transition between the pool room roof and the adjoining main house wall/roof, with waviness and lifting consistent with the conditions noted on the adjacent pool room section. Ceiling structure showed signs of water intrusion, which could lead to more serious structural damage and/or mold.

Roof transitions of this type rely on properly installed step flashing, kick-out flashing, and underlayment; probable leakage at this location indicates a deficiency in the roofing/flashing system.

**Recommendation:** Recommend immediate evaluation and repair by a licensed roofing contractor.

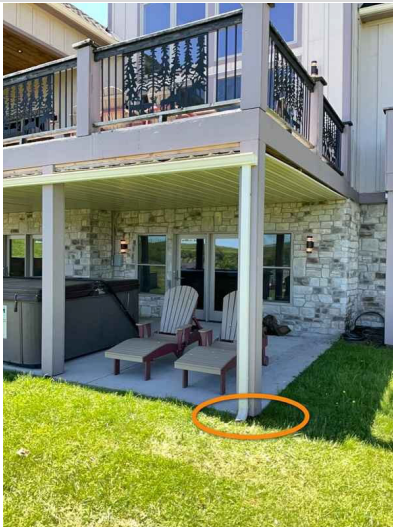
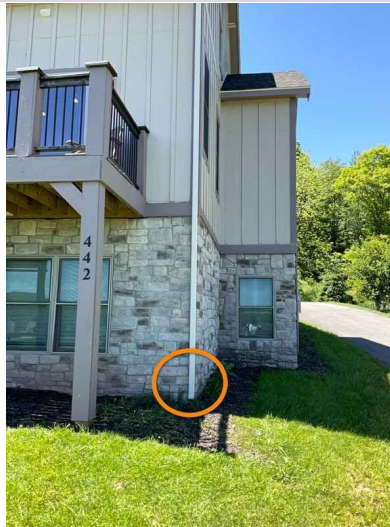
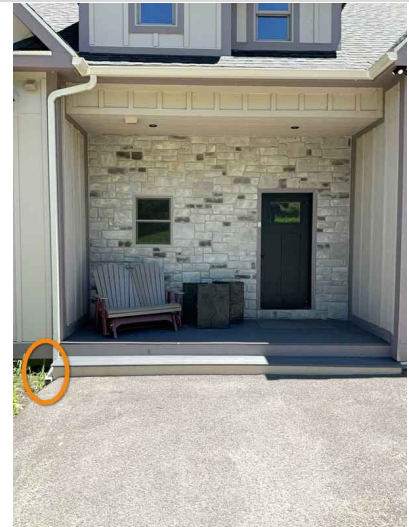
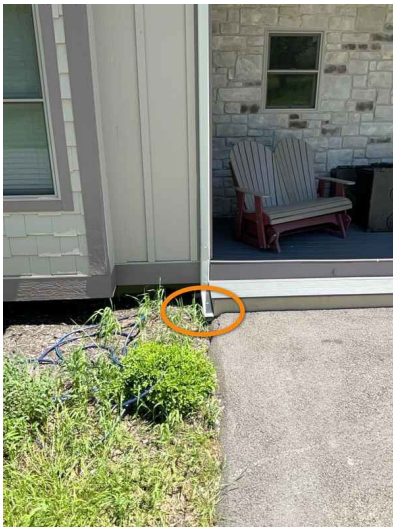
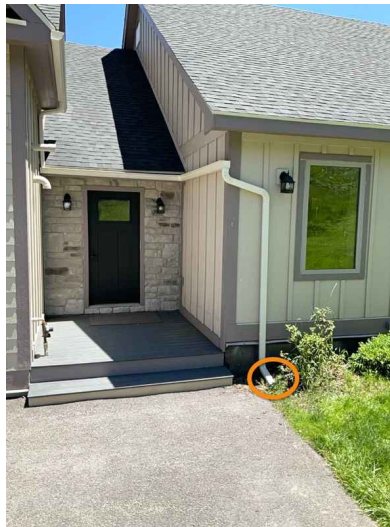
#### DOWNSPOUTS DRAIN NEAR HOUSE

One or more downspouts drain too close to the home foundation. This can result in excessive moisture in the soil at the foundation, which can lead to foundation/structural movement.

**Recommendation:** Recommend a qualified contractor adjust downspout extensions to drain at least 6 feet from the foundation.

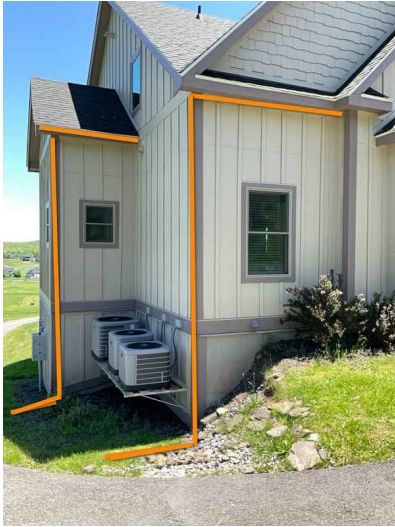
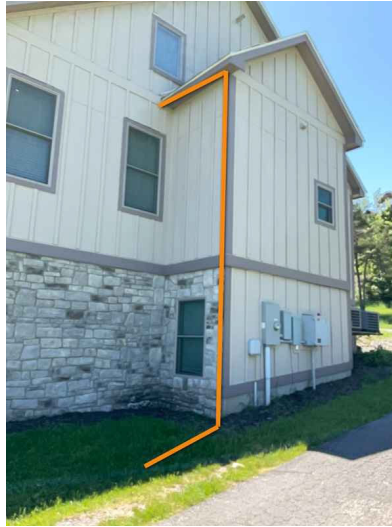
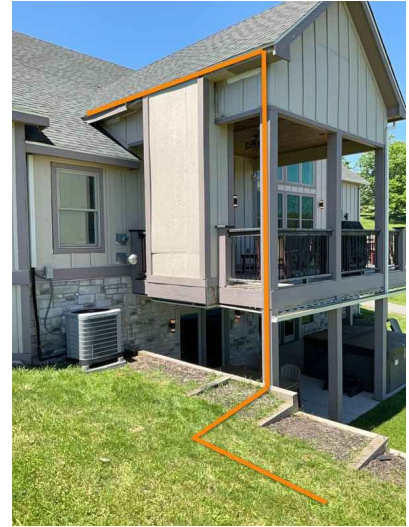
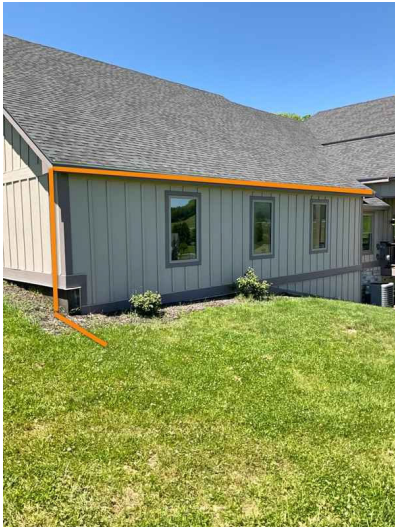
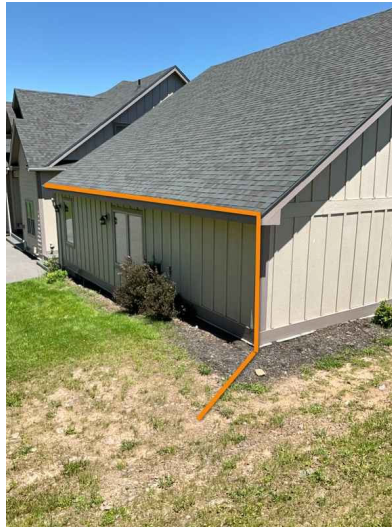
#### GUTTERS MISSING

One or more roof edges lack gutters. Additional gutter installation is recommended because gutters collect rainwater from the roof and direct it away from the building. This would help prevent soil erosion and water intrusion.

**Recommendation:** Contact a qualified roofing professional.

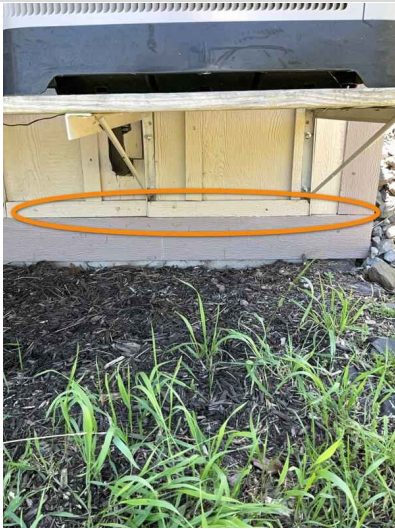
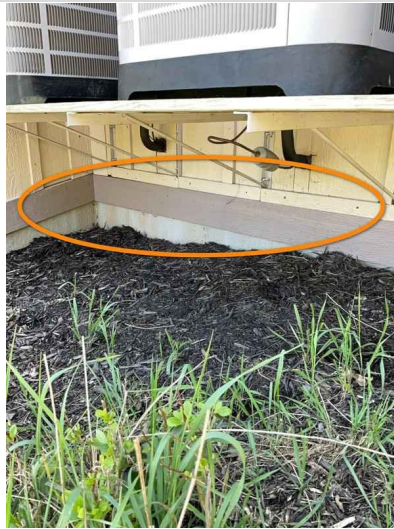
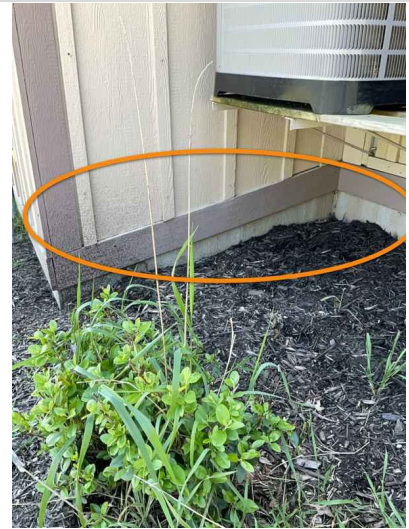
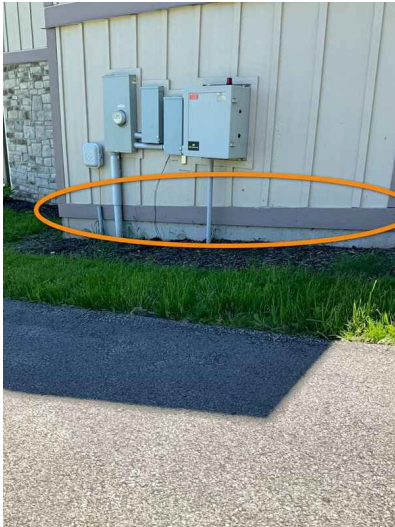
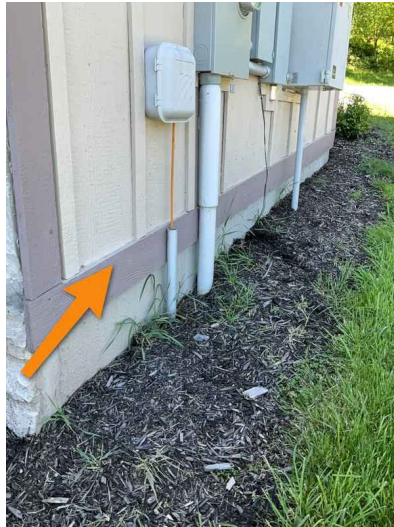
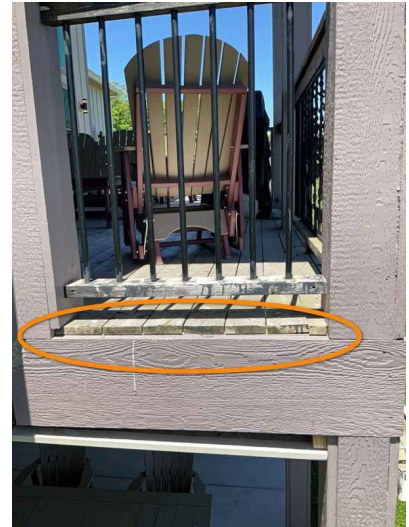
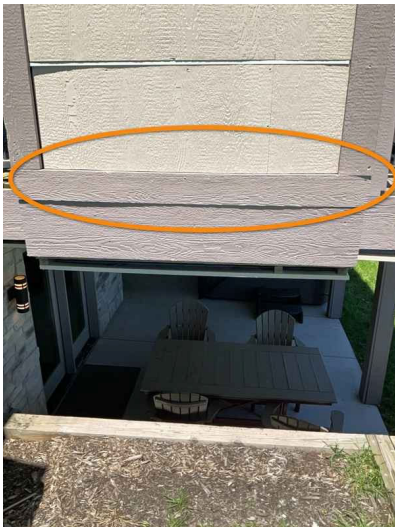
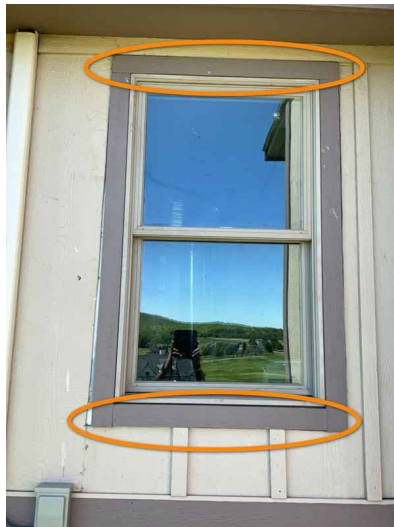
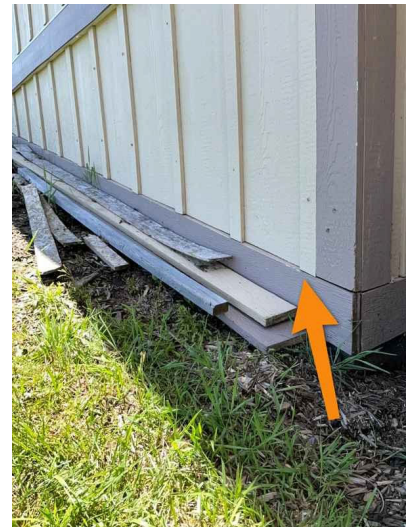
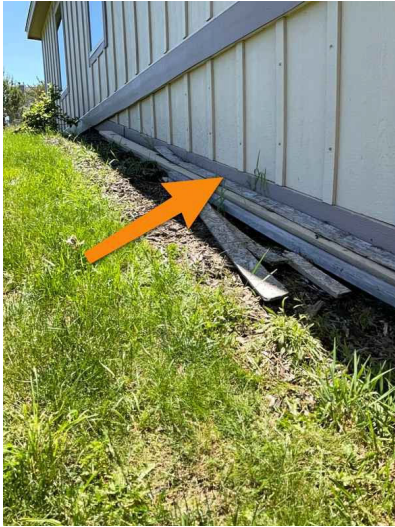
#### MISSING FLASHING & CAULKING

Some flashings and caulking were missing around openings and at junctions of siding and trim at the time of inspection. Flashing and caulking provide protection against moisture intrusion.

**Recommendation:** Recommend evaluation and correction by a qualified general contractor.

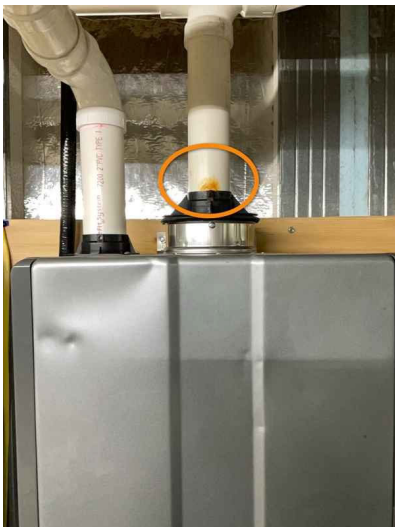
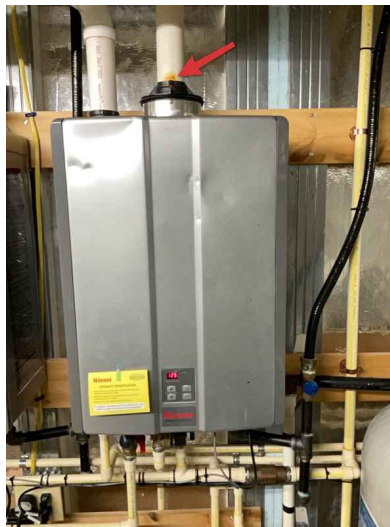
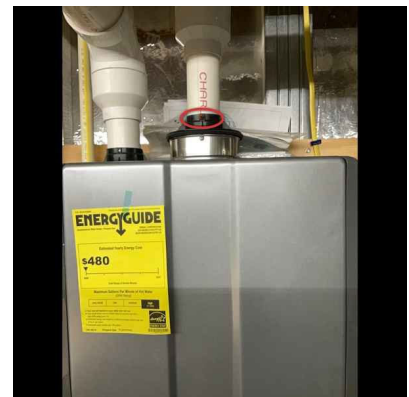
##### CORROSION

- Tankless Water Heater Vent Corrosion - corrosion and staining were observed at the exhaust vent connection of one tankless water heater. This condition may indicate condensate leakage and/or combustion gas leakage at the vent connection. Evaluation and repair by a qualified plumbing or gas appliance contractor is recommended.

Staining and corrosion-type deposits were observed at the exhaust vent connection on top of the gas tankless water heater, where the PVC venting meets the unit vent collar.

Deposits at this location can indicate condensate and/or combustion-gas leakage at the vent joint, which may result from a loose or improperly sealed connection, a failed gasket, or improper venting. Leakage at an exhaust connection raises both corrosion and combustion-safety (carbon monoxide) concerns.

**Recommendation:** Recommend immediate evaluation and repair by a licensed plumber or qualified gas appliance technician prior to continued use. A carbon monoxide alarm should be confirmed present and functional in the area.

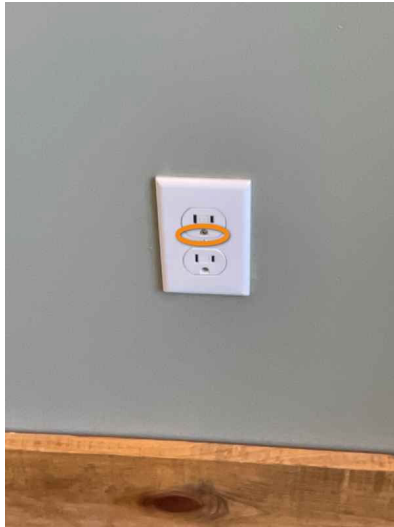
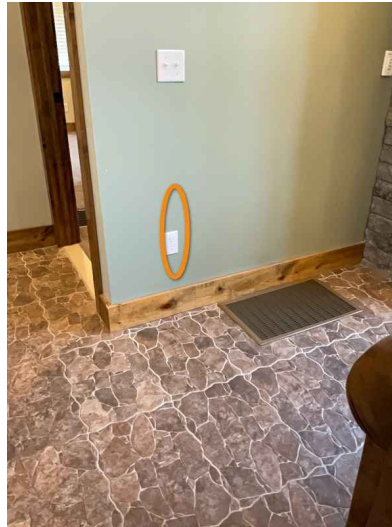
### DAMAGED OUTLET

- Damaged Electrical Receptacle - a broken plug prong remains lodged within a receptacle adjacent to the great room fireplace. This condition presents a potential shock and arcing hazard. Replacement by a qualified electrician is recommended.

A broken plug prong remains stuck within the receptacle. A foreign metal object in an energized receptacle is a shock and arcing/fire hazard. The receptacle cannot be safely used.

**Recommendation:** Recommend a qualified electrician de-energize the circuit, remove the broken prong, and replace the receptacle immediately.

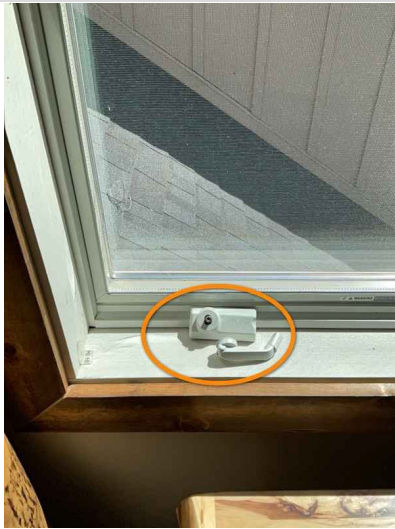
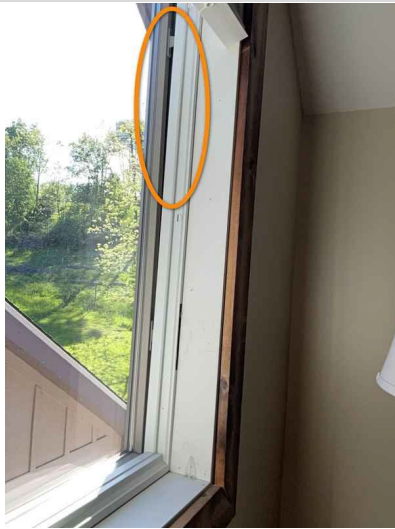
### DAMAGED

An upstairs bedroom window is not closing properly and the crank is not secured. This condition could potentially allow moisture intrusion.

**Recommendation:** Recommend a window professional clean, lubricate, adjust, and repair as necessary.

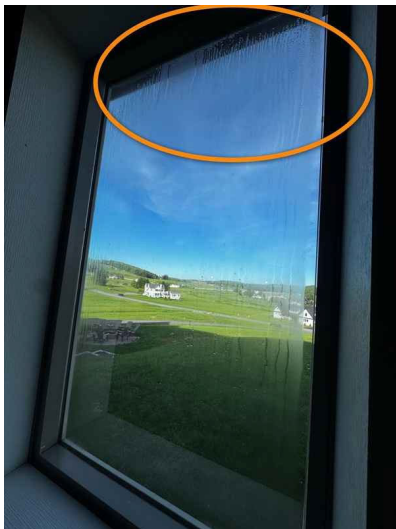
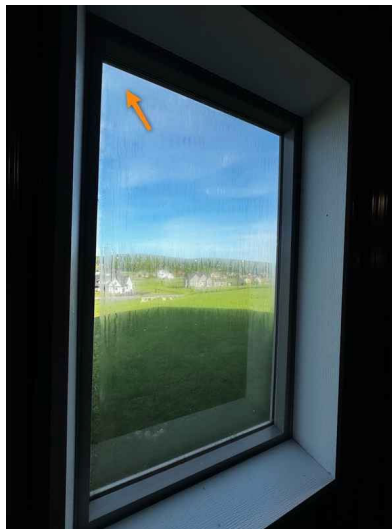
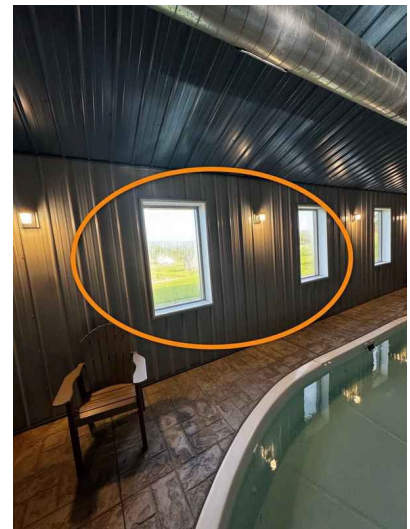
##### FAILED SEAL

- Failed Window Seal - condensation was observed between glazing panes in the pool room window assembly, indicating failure of the insulated glass seal. Replacement of the affected glazing unit is recommended.

Condensation was observed between the window panes in the pool room, which indicates a failed seal.

**Recommendation:** Recommend evaluation and replacement by a qualified window contractor.

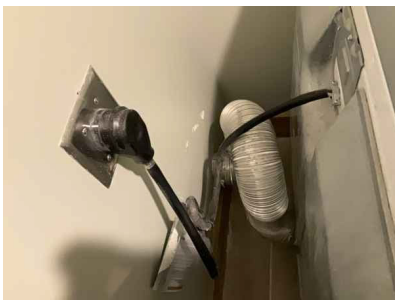
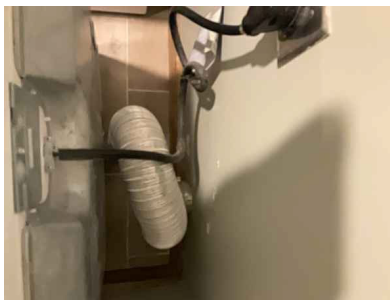
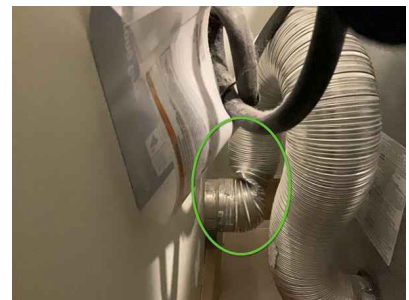
##### DRYER DUCT CRIMPED

- Dryer Exhaust Restriction - the dryer exhaust duct was observed to be significantly crimped behind the appliance. Restricted airflow can increase lint accumulation and elevate fire risk. Correction and cleaning of the vent system is recommended.

The dryer exhaust duct was observed to be crimped/kinked behind the dryer and at the wall connection.

A crimped duct restricts exhaust airflow, which promotes lint accumulation and elevated operating temperatures, a recognized fire hazard. Restricted dryer venting also reduces drying efficiency and can shorten appliance life.

**Recommendation:** Recommend the duct be corrected to allow unrestricted airflow. Combustible vinyl/plastic transition duct, if present, should be replaced with smooth rigid or UL-listed semi-rigid metal duct. The full duct run should be cleaned of lint.

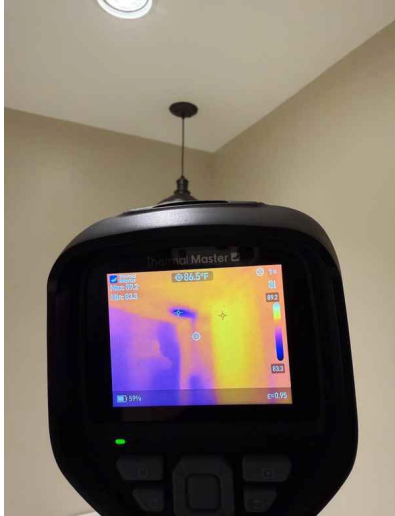
## POWDER ROOM THERMAL DIFFERENTIAL

Pool room right upper part of ceiling showed a thermal differential. This may be caused by moisture intrusion, insulation displacement, or air infiltration. This area is beneath the sagging pool room roof and may have moisture intrusion.

A moisture meter detected a normal reading at the time of the inspection; however, moisture conditions can change with weather, season, and roof/plumbing performance.

**Recommendation:** Evaluation by a qualified contractor is recommended.
