THOROUGHbred PROPERTY INSPECTIONS LLC

## RESIDENTIAL REPORT

SAMPLE ONLY

05/31/2026

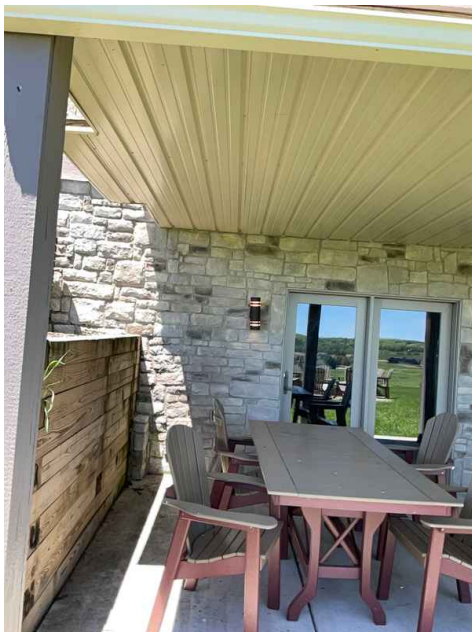
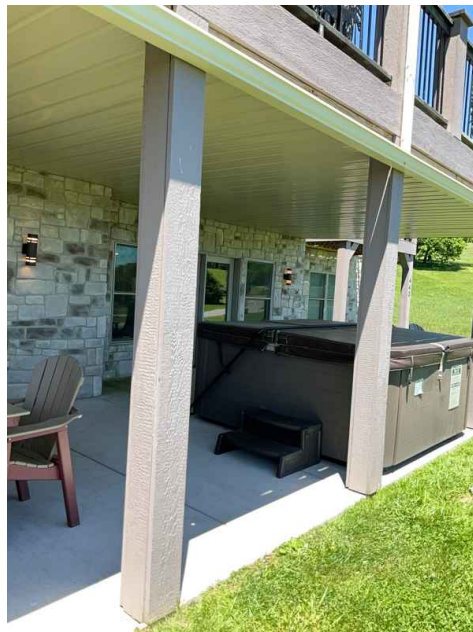
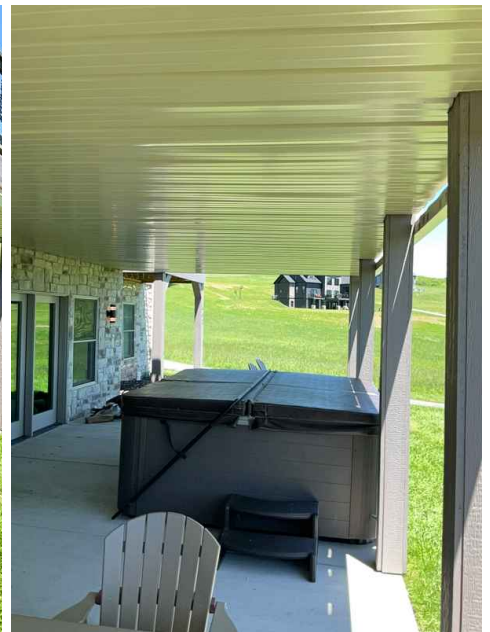
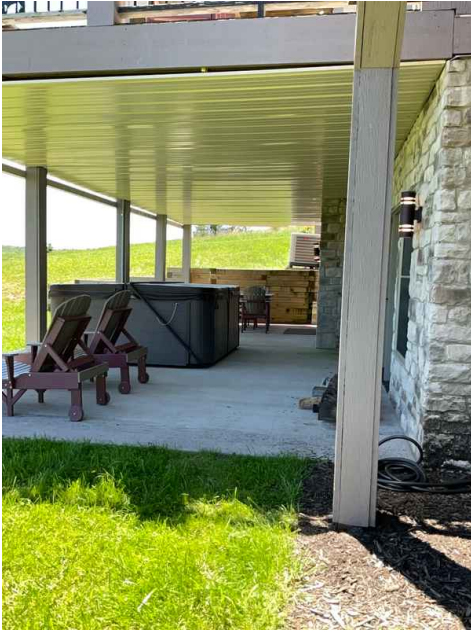
REAR DECK

Was unable to inspect deck structures due to undersurface being covered with undercover rain management equipment.

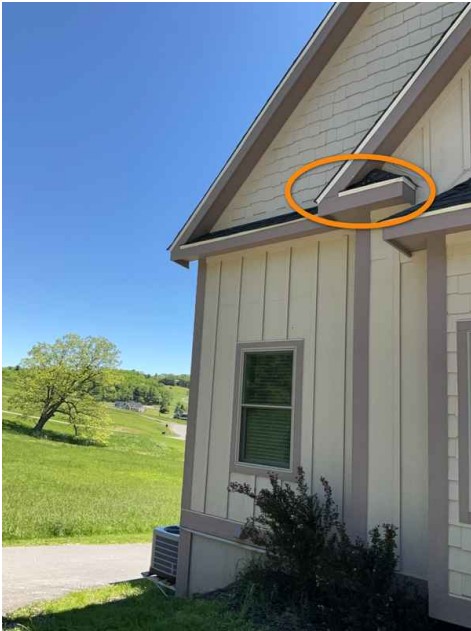
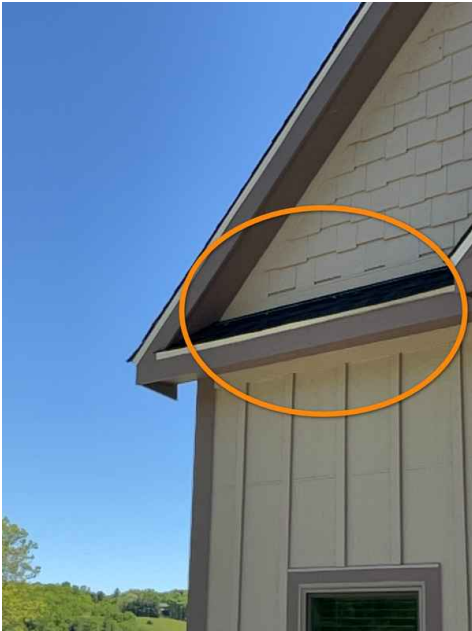
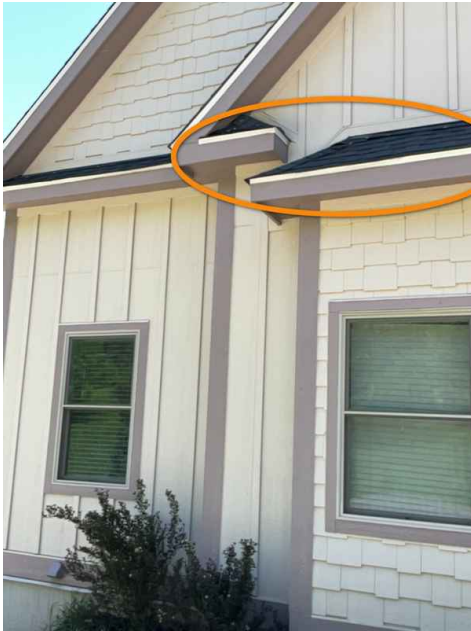
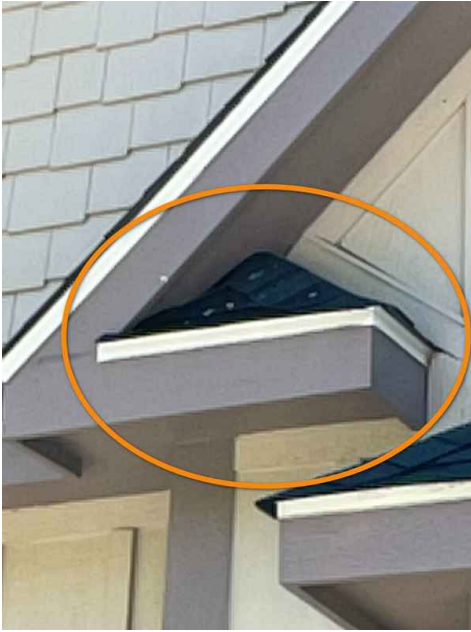
2.2.1 Siding, Flashing & Trim

Open gaps were observed at the decorative gable projections where the roof meets the wall (roof-to-wall intersection), at the front of the home. These gaps create a potential pathway for water to enter behind the siding and trim. Over time this can lead to concealed moisture damage, wood rot, and interior staining. Recommend evaluation and repair by a licensed roofing or siding contractor to properly flash and seal these areas within next 6 to 12 months.

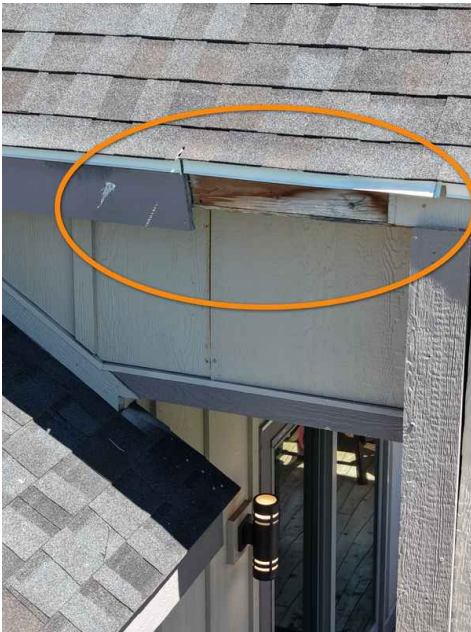
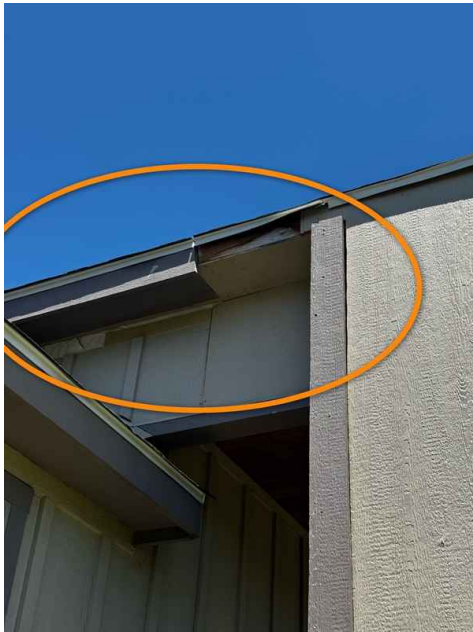
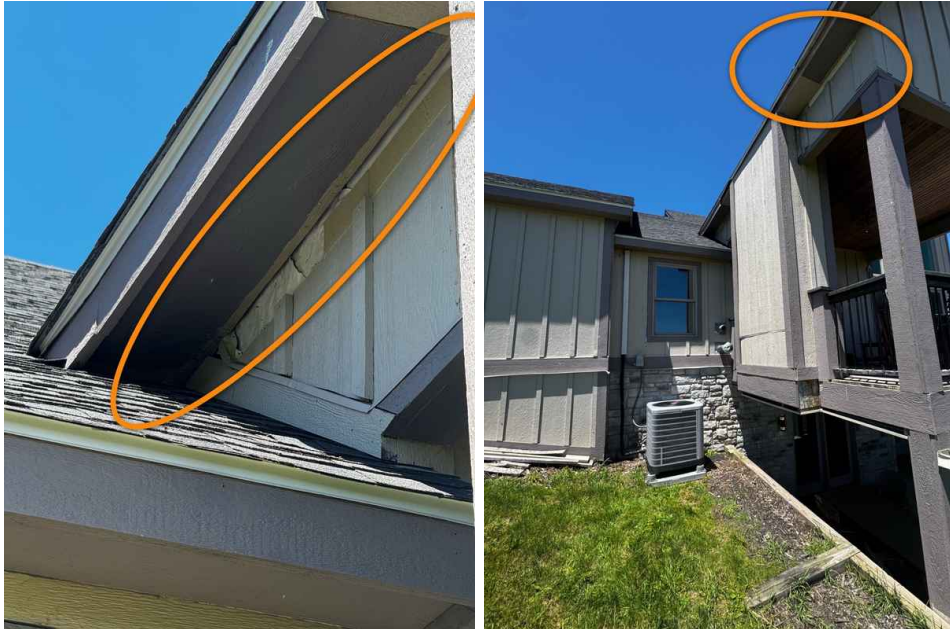
2.2.2 Siding, Flashing & Trim  
**MISSING SIDING/TRIM**

The siding and trim behind outdoor fireplace is missing siding and trim. These gaps create a potential pathway for water to enter behind the siding and trim. Over time this can lead to concealed moisture damage, wood rot, and interior staining. Recommend evaluation and repair by a qualified siding contractor immediately.

Recommendation  
Contact a qualified siding specialist.

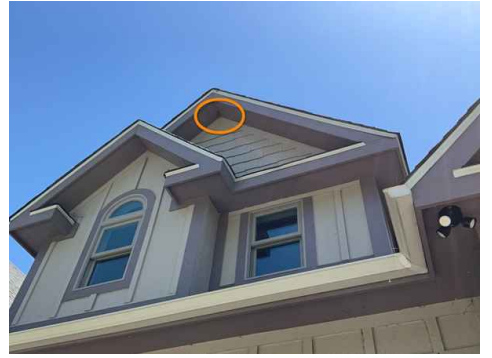
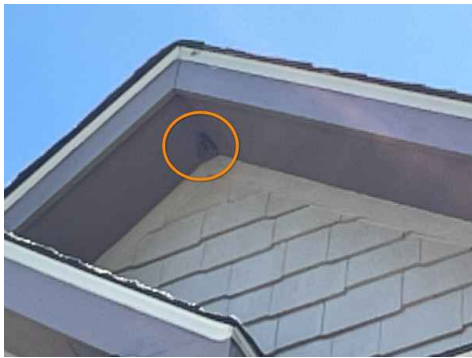
Wasp or hornet nests were observed at exterior roof peaks. Removal by a qualified pest-control professional is recommended.

Recommendation

Contact a qualified pest control specialist.

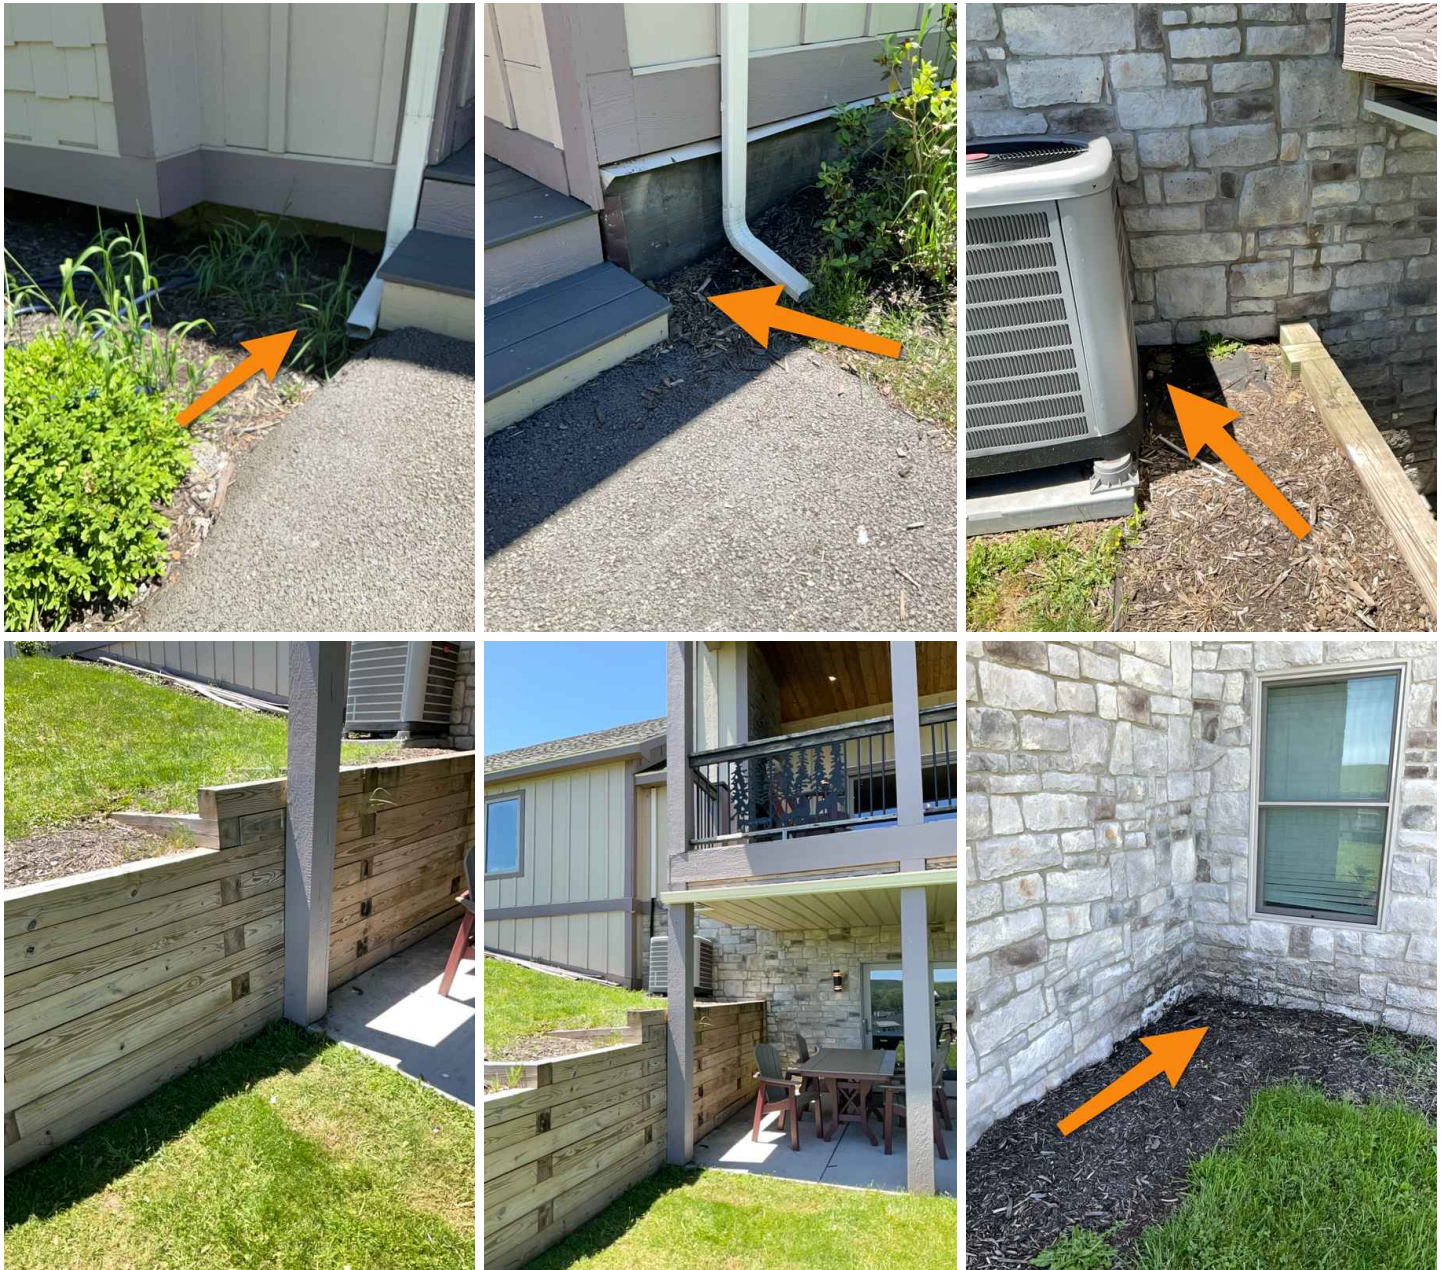
### 2.6.1 Vegetation, Grading, Drainage & Retaining Walls

#### **NEGATIVE GRADING**

Contact a qualified grading contractor.

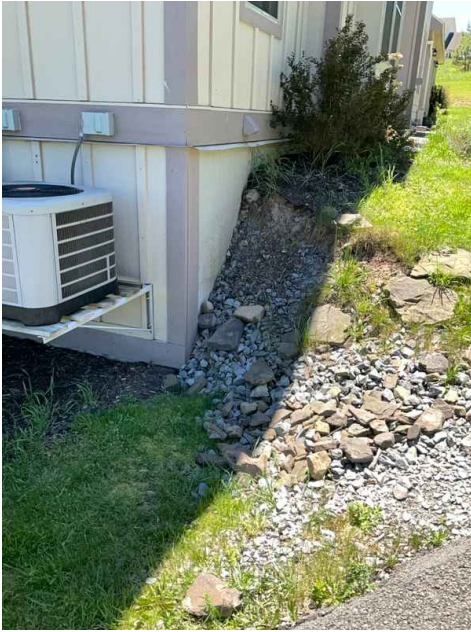
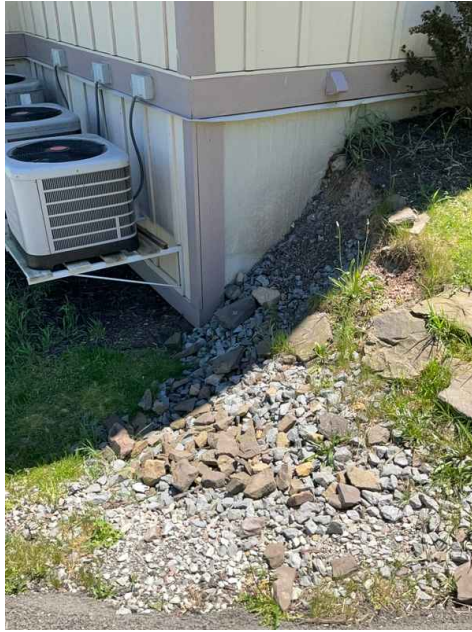
Localized soil erosion was observed along the foundation at the front, left corner. Erosion of this type can undermine soil-bearing support and allow water to reach the foundation and crawlspace. Recommend evaluation and correction by a qualified grading/drainage contractor.

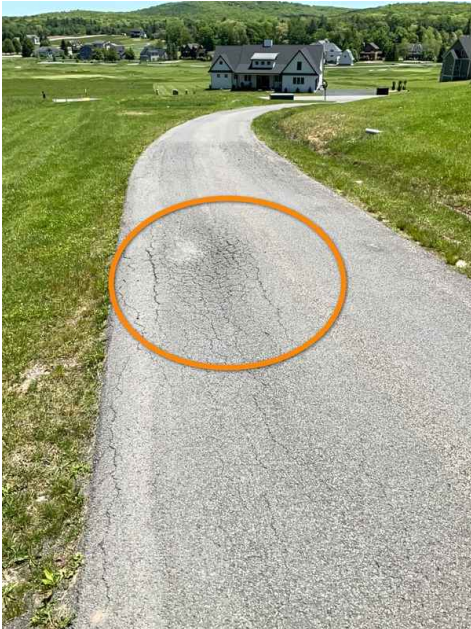
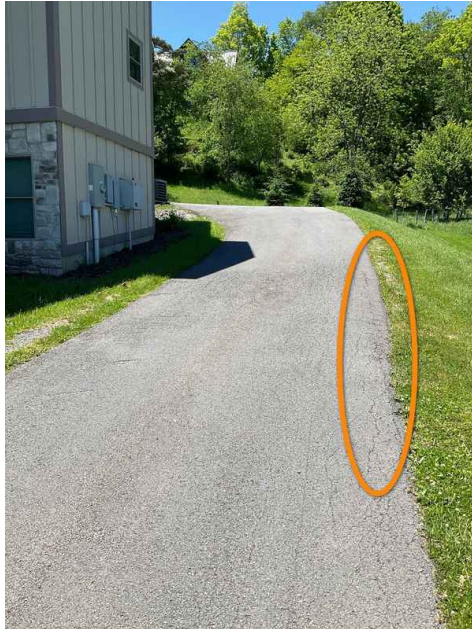
2.7.1 Walkways, Patios & Driveways

Minor cosmetic cracks observed, which may indicate movement in the soil. Recommend you monitor and/or have driveway contractor patch/seal.

Recommendation  
Recommend monitoring.

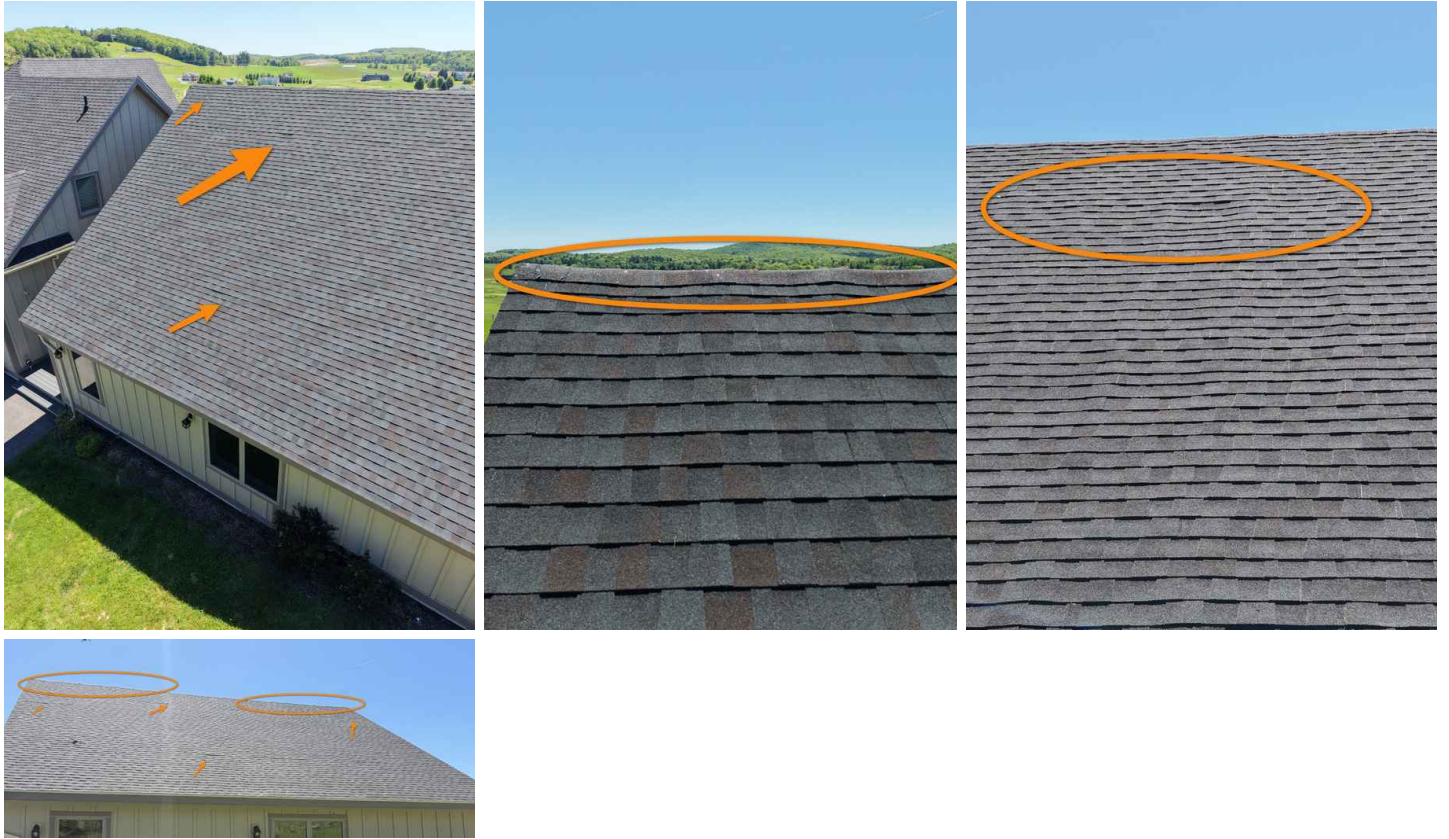
The roof covering over the pool room exhibits noticeable waviness/undulation in the roof plane, and the ridge cap shingles are lifting in several locations. In a high-humidity pool environment, deformation of this type is frequently associated with moisture within the roof assembly (e.g., condensation on the underside of the roof sheathing) and/or installation deficiencies, though the cause could not be confirmed without further evaluation. The interior of this room has metal wall and ceiling finishes, which do not display the staining typically associated with concealed moisture. Therefore, the absence of visible interior water staining should not be interpreted as the absence of moisture intrusion or concealed damage. This is a significant condition. Recommend immediate evaluation and repair by a licensed roofing contractor experienced with roof assemblies over high-humidity/pool spaces, including assessment of the roof deck, attic/assembly ventilation, and moisture conditions..

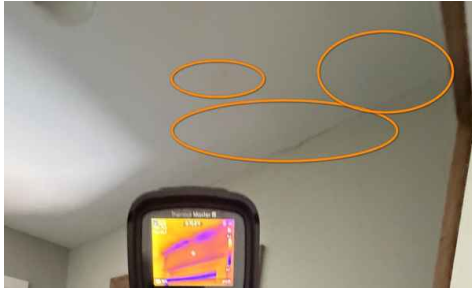
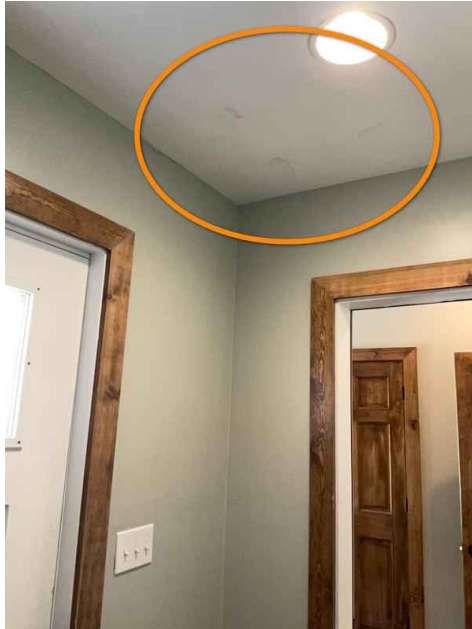
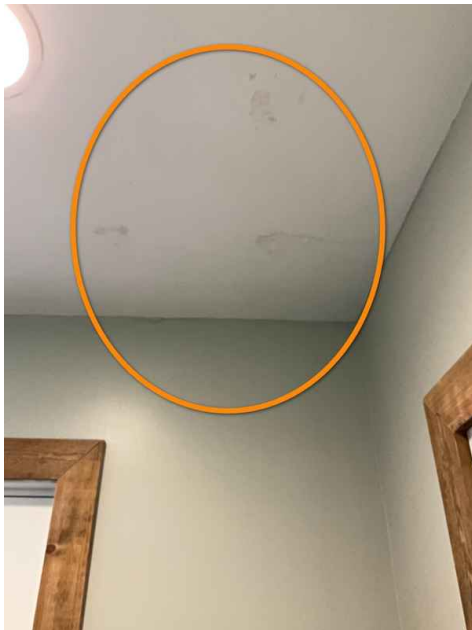
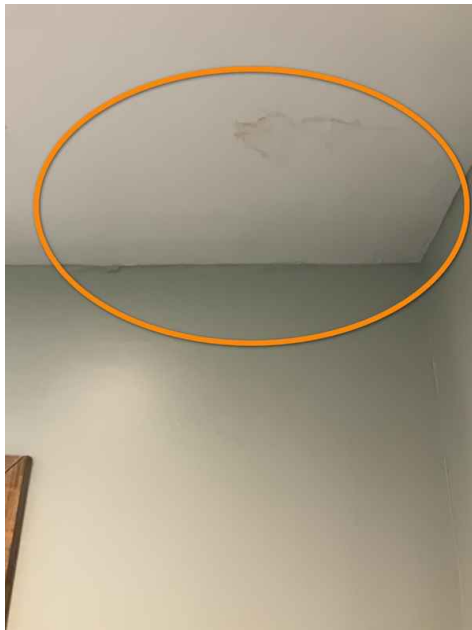
The roof covering above the pool room exhibits noticeable waviness and ridge-cap displacement. Because the pool room is a high-humidity environment, these conditions may indicate moisture-related deterioration within the roof assembly. Further evaluation by a qualified roofing contractor experienced with pool-room assemblies is recommended.

Contact a qualified roofing professional.

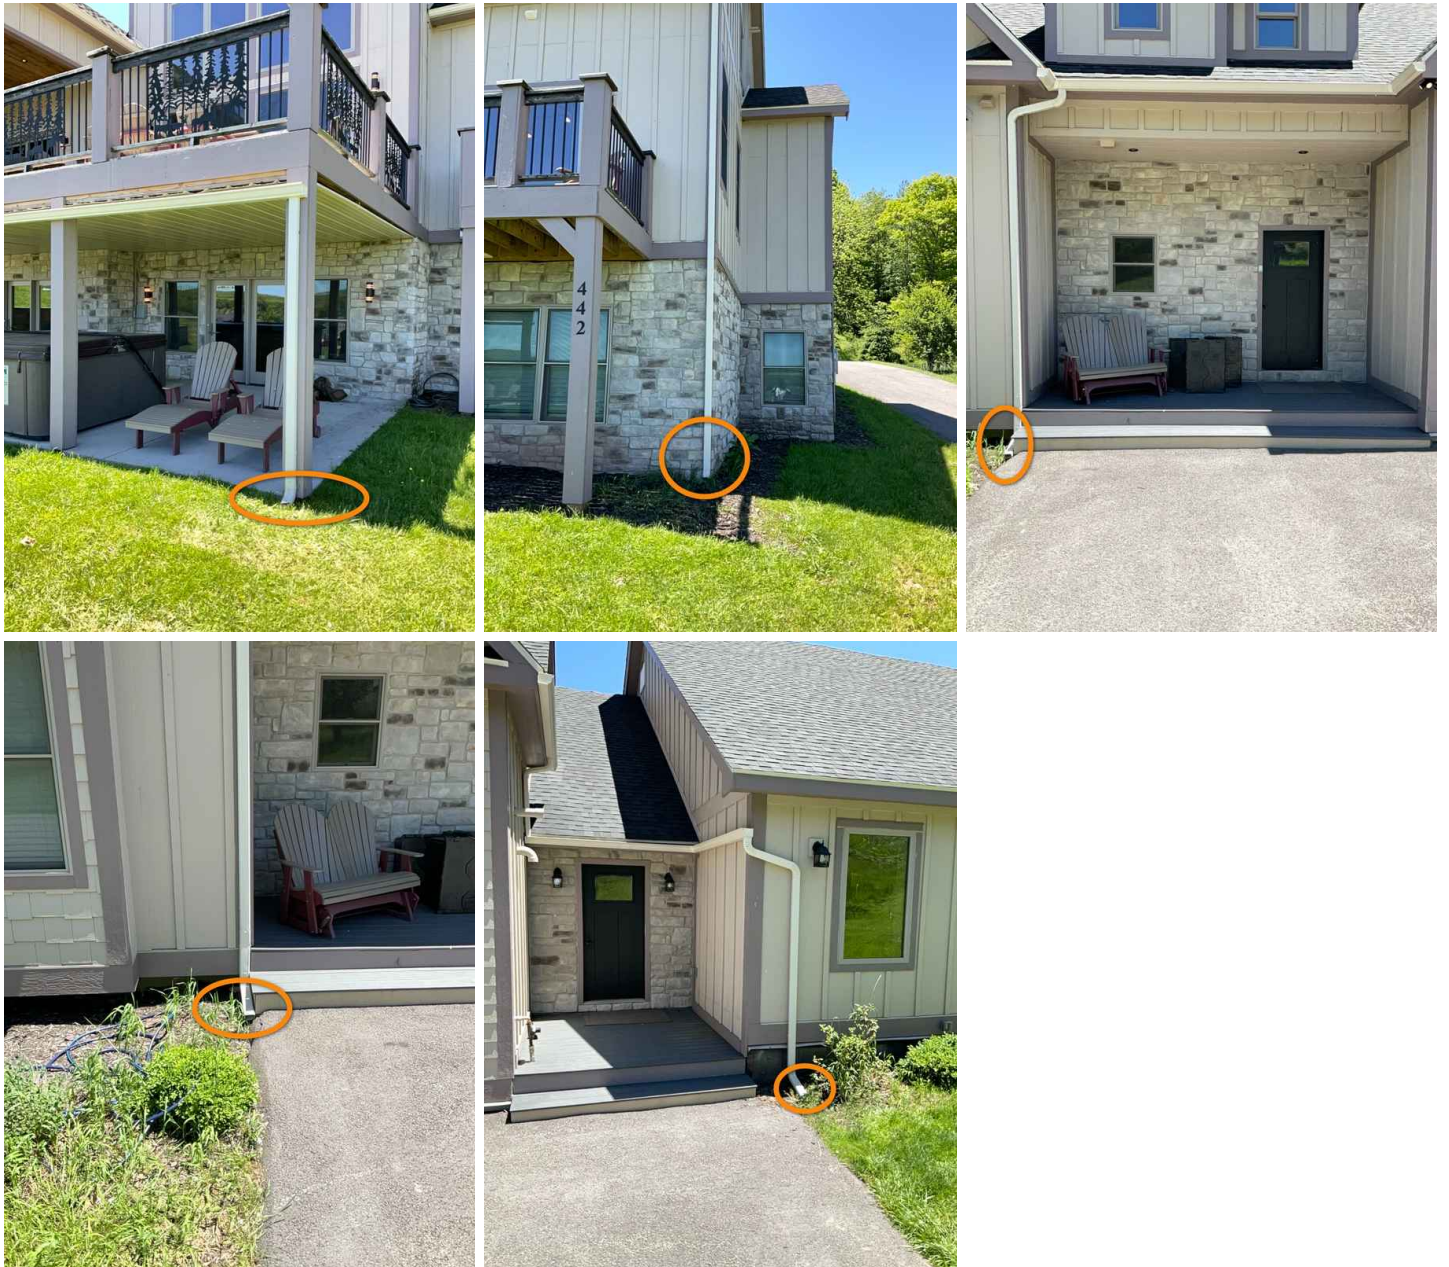
One or more downspouts drain too close to the home's foundation. This can result in excessive moisture in the soil at the foundation, which can lead to foundation/structural movement. Recommend a qualified contractor adjust downspout extensions to drain at least 6 feet from the foundation.

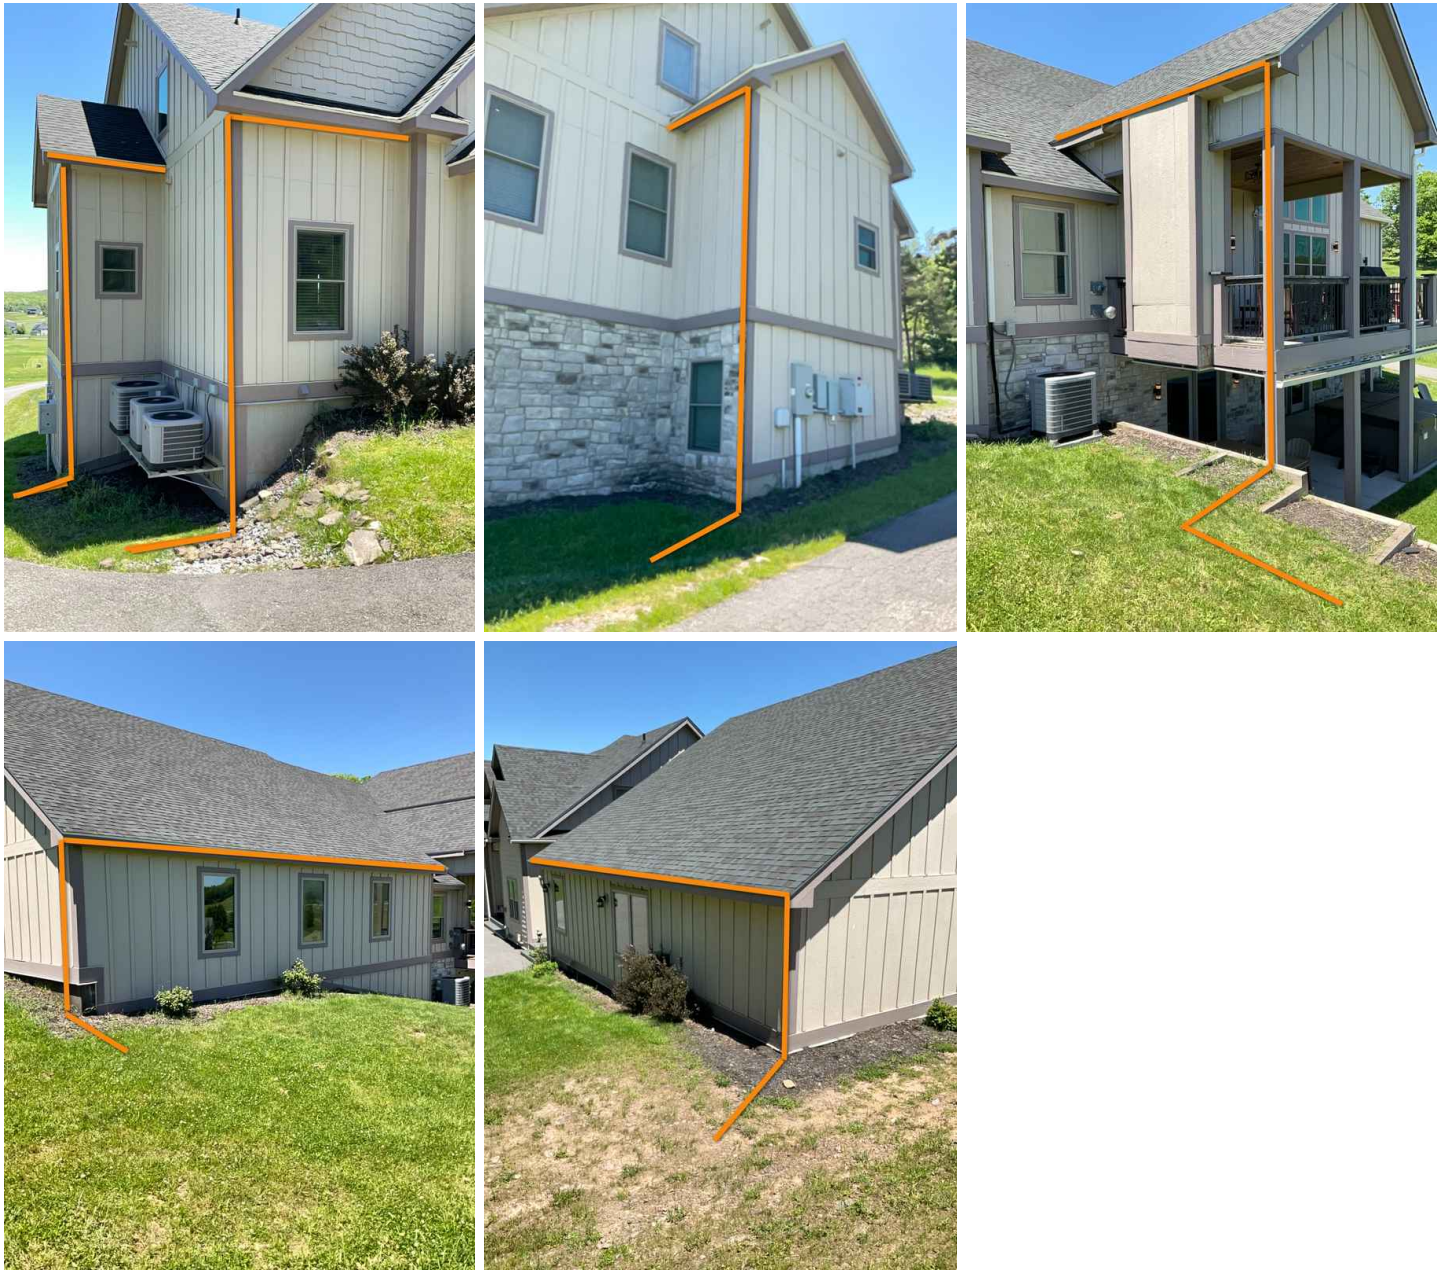
3.2.2 Roof Drainage Systems

One or more roof edges lack gutters. Additional gutter installations by a professional are recommended because they collect rainwater from the roof and direct it away from the building. This would help prevent soil erosion and water intrusion.

Contact a qualified roofing professional.

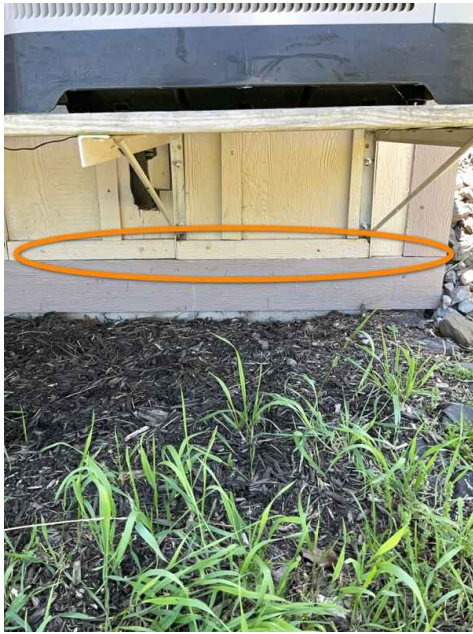
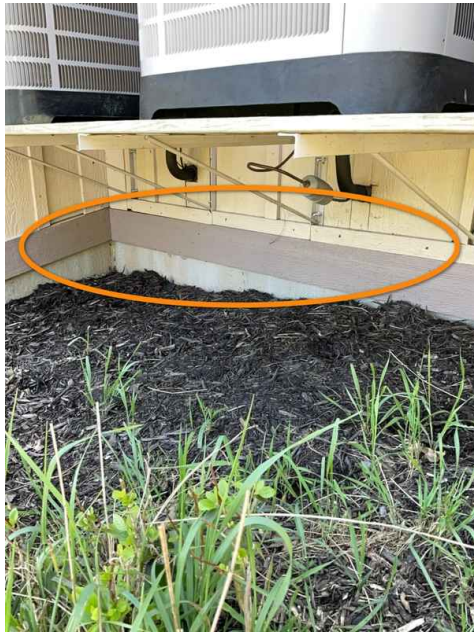
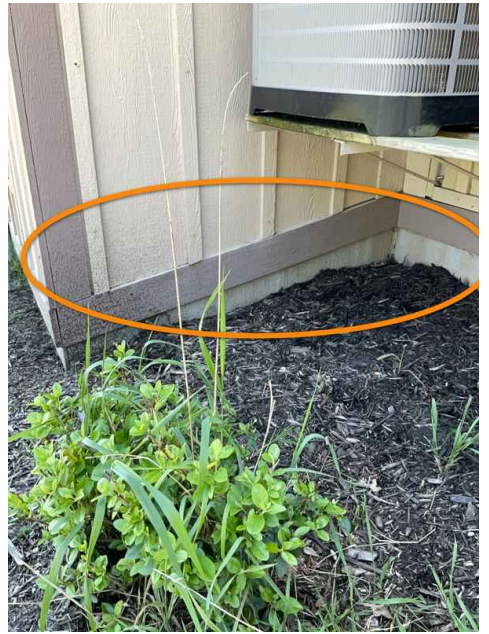
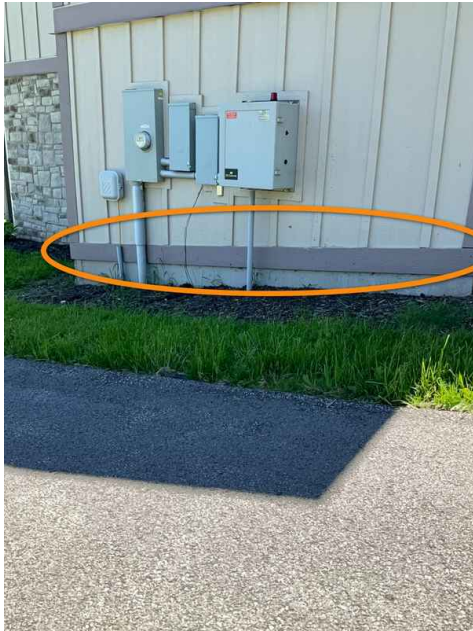
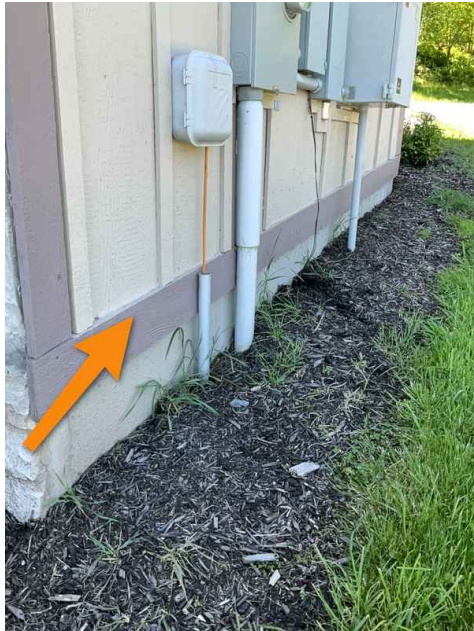
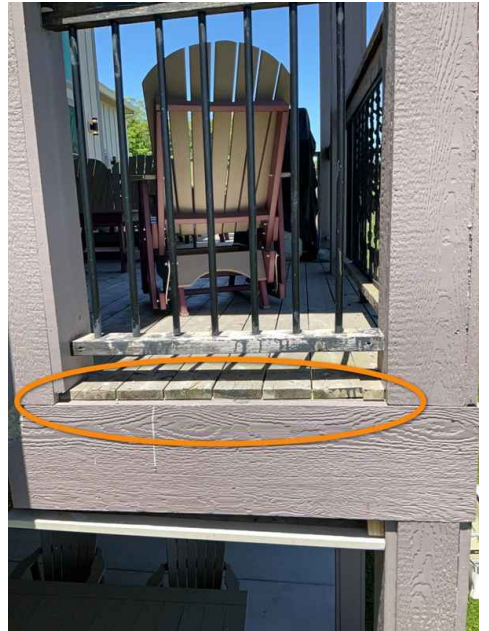
3.3.1 Flashings

Some flashings and caulking were missing around some openings and at junctions of siding and trim at time of inspection. Flashing and caulking provide protection against moisture intrusion. Recommend a qualified contractor evaluate and remedy.

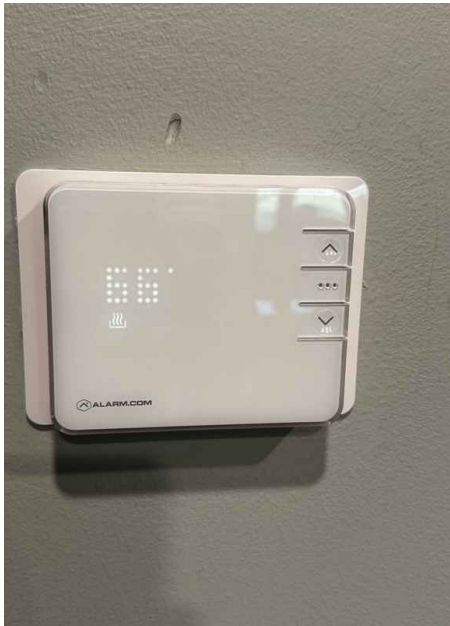
## Normal Operating Controls: Wall mounted thermostats

Two wall mounted programmable, smart thermostats, were present and appeared operational at the time of inspection. The thermostats were responsive to use or controls and displayed a heating set point of 66°F. Functional testing of both thermostats were limited to normal operating controls. Long-term performance and calibration cannot be determined during a visual home inspection.

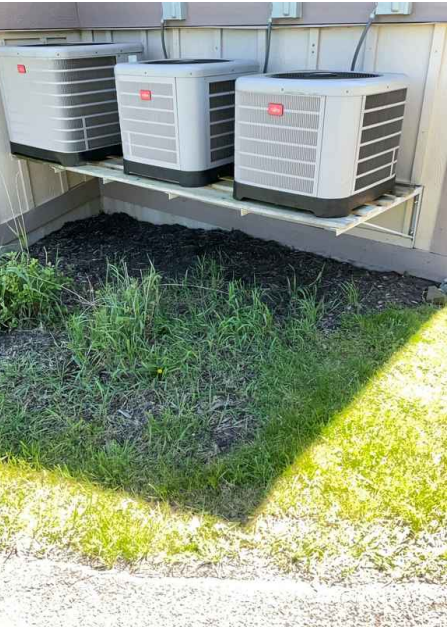
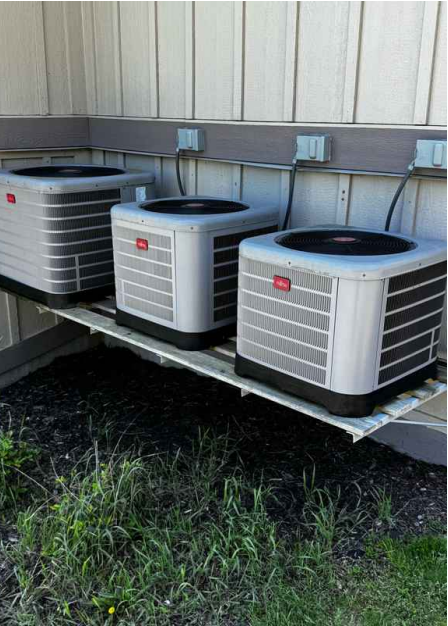
Five outdoor air conditioning/heat pump condensing units or present and mounted on an elevated Support platform adjacent to the exterior wall. The unit units appeared properly secured and in generally serviceable condition at the time of inspection. Representative operation was performed through normal controls, and the systems responded as intended. No unusual vibration excessive noise or visible damage was observed. The condenser coils appeared reasonably clean. Electrical disconnects were present and adequate service clearances were observed around the units. Elevated mounting helps protect the equipment from snow accumulation, standing water and surface debris. Vegetation growth was noted beneath the platform, however it was not interfering with the operation of the equipment at the time of inspection.

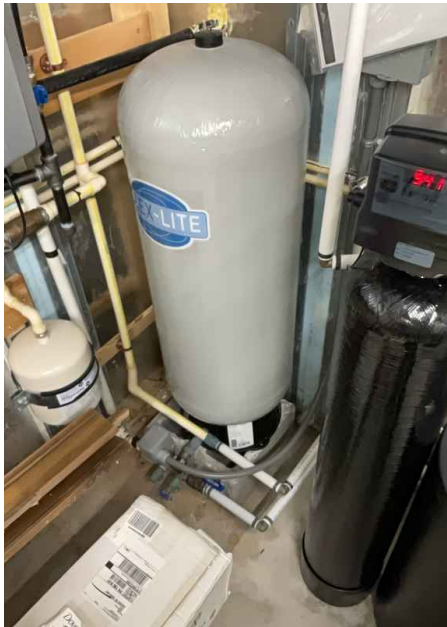
##### Water treatment system

The whole house water treatment system was installed and appeared to consist of a water softener, conditioning unit, pressure tank, ultraviolet water, disinfection system, and associated treatment components. The system appeared operational at the time of inspection based on visible indicators and equipment status displays. Water treatment equipment was not evaluated for treatment effectiveness or water quality for a long-term performance as these require specialized testing and maintenance records. The presence of a UV sterilizer and multiple treatment devices often suggests that the water source has required treatment for bacteria, hardness, iron, sulfur, or other water quality concerns at some point.

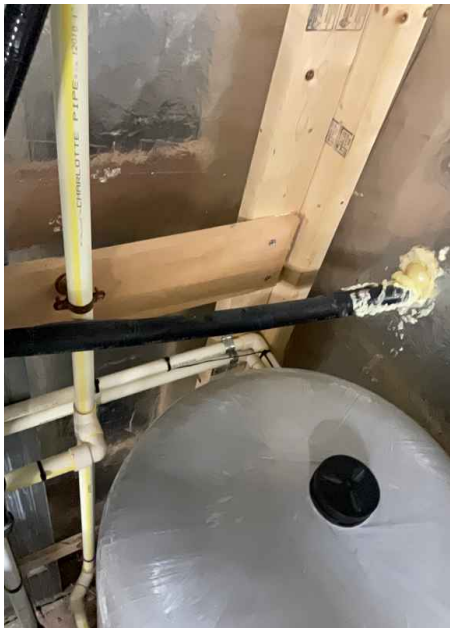
The visible main water supply piping at the wall penetration, appears to be polyethylene PE piping commonly used material for private well water service lines. No active leakage was observed at visible portions of the piping at the time of the inspection. spray foam sealant was observed around the water service line penetration. The foam appeared to be serving as an air and pest barrier. No deficiencies were observed at the visible portions at the time of the inspection.

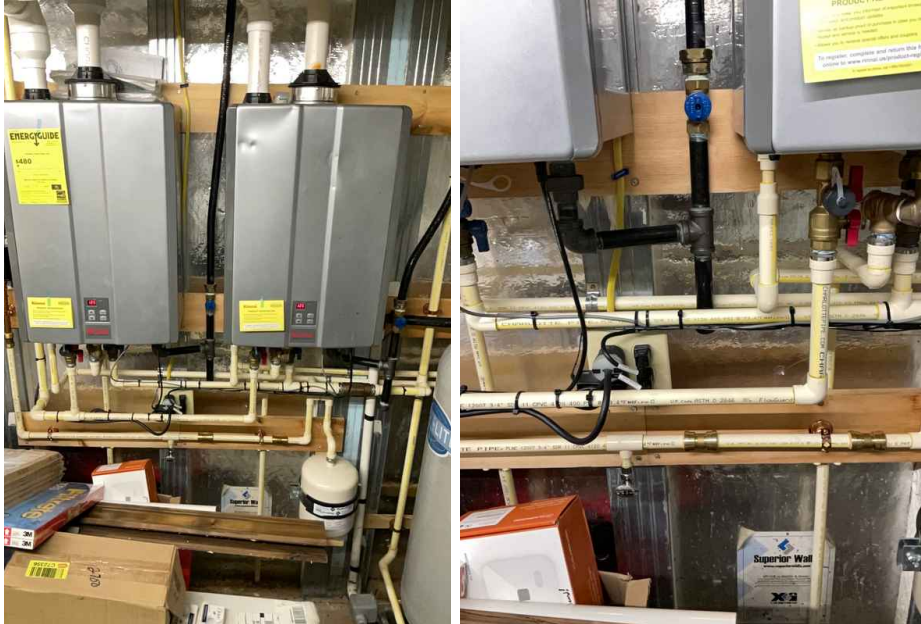
Two gas fired Rinnai tankless water heaters were installed in a parallel configuration to provide domestic hot water. Visible portions of the installation appear generally functional at the time of inspection with no active leakage observed. Routine servicing and descaling in accordance with manufacturer recommendations is advised to help maximize service life and performance.

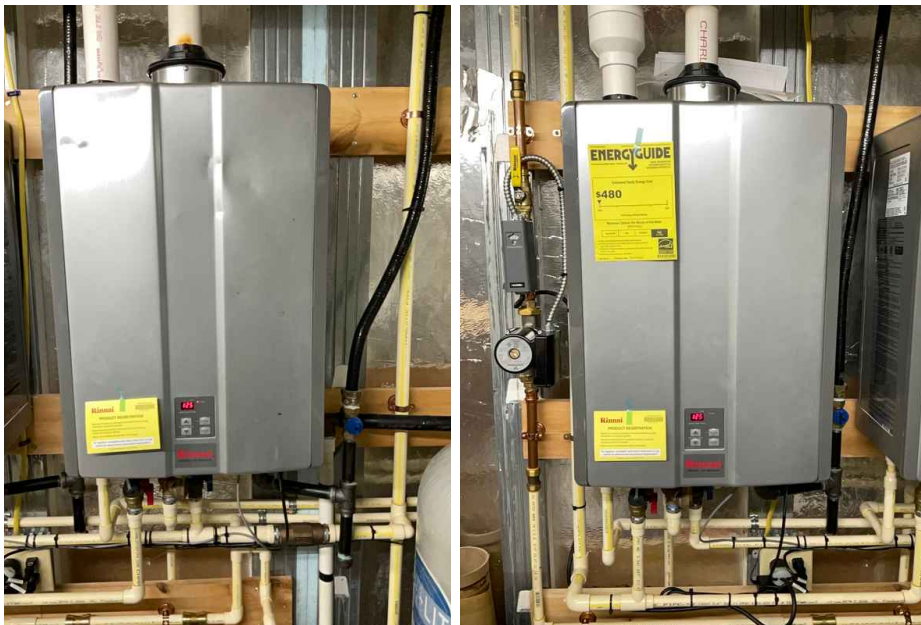
I recommend flushing & servicing your water heater tank annually for optimal performance. Water temperature should be set to at least 120 degrees F to kill microbes and no higher than 130 degrees F to prevent scalding.

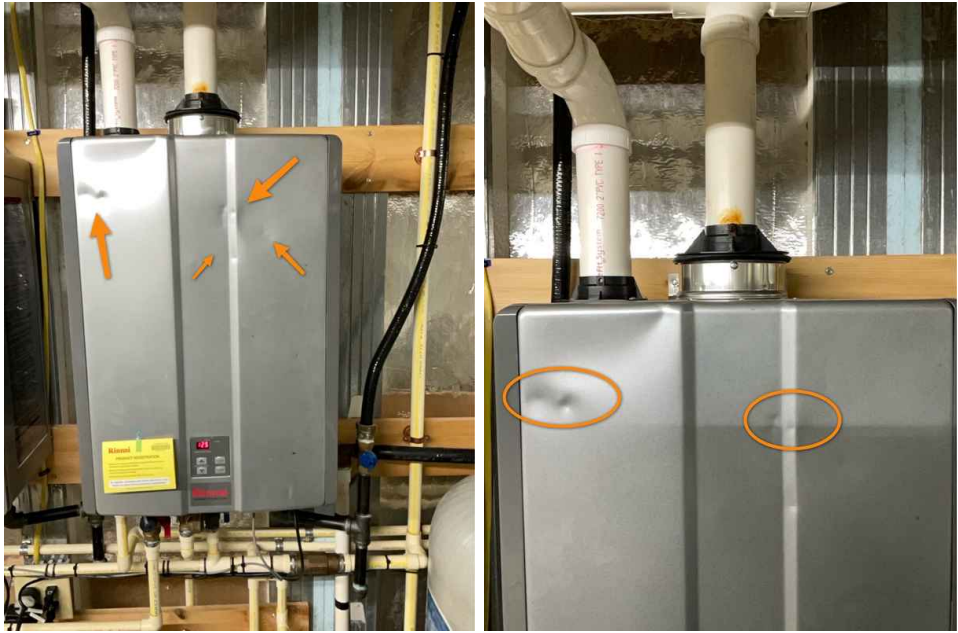
### DENTS ON TANKLESS WATER HEATER

The right side unit has a small dent in the front cover. This appears cosmetic and does not necessarily indicate an operational issue, but the internal components were not evaluated. Would recommend for the evaluation by (HVAC) professional.

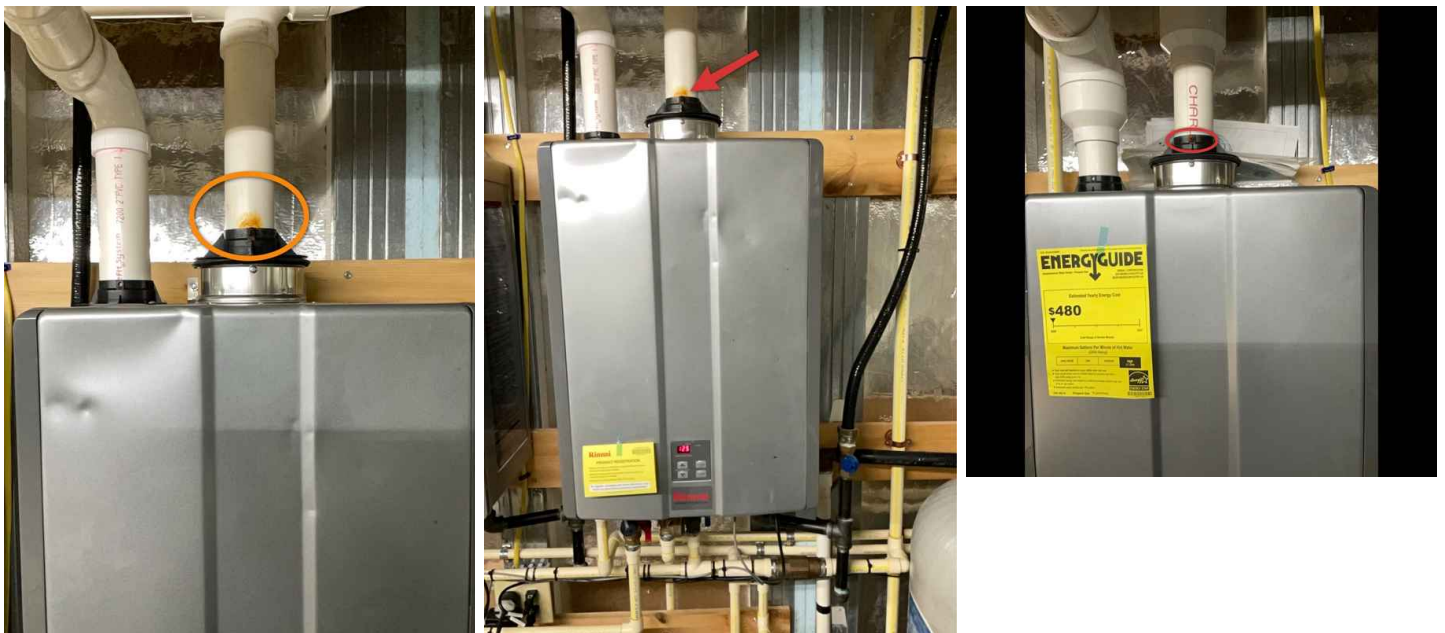
### 7.4.1 Hot Water Systems, Controls, Flues & Vents

Staining and corrosion-type deposits were observed at the exhaust vent connection on top of the gas tankless water heater, where the PVC venting meets the unit's vent collar.

Deposits at this location can indicate condensate and/or combustion-gas leakage at the vent joint, which may result from a loose or improperly sealed connection, a failed gasket, or improper venting. Leakage at an exhaust connection raises both corrosion and combustion-safety (carbon monoxide) concerns.

Recommend immediate evaluation and repair by a licensed plumber or qualified gas appliance technician prior to continued use. A carbon monoxide alarm should be confirmed present and functional in the area.

Contact a qualified plumbing contractor.

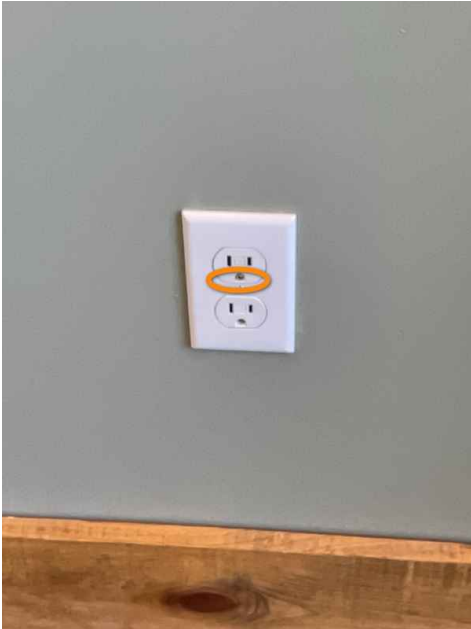
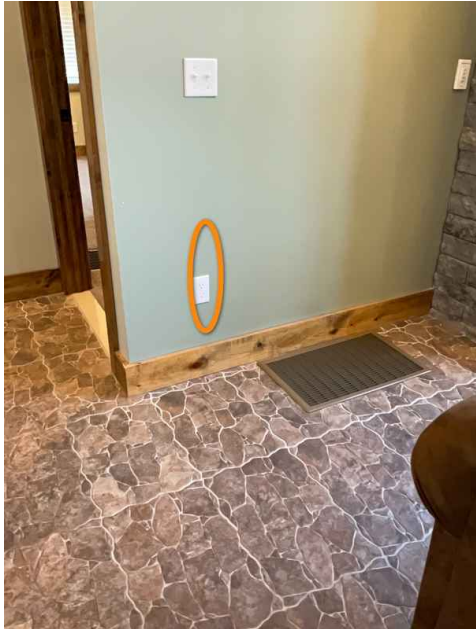
### 8.4.1 Lighting Fixtures, Switches & Receptacles

A broken plug prong remains stuck within receptacle. A foreign metal object in an energized receptacle is a shock and arcing/fire hazard. The receptacle can't be safely used. Recommend a qualified electrician de-energize, remove it and replace the receptacle immediately.

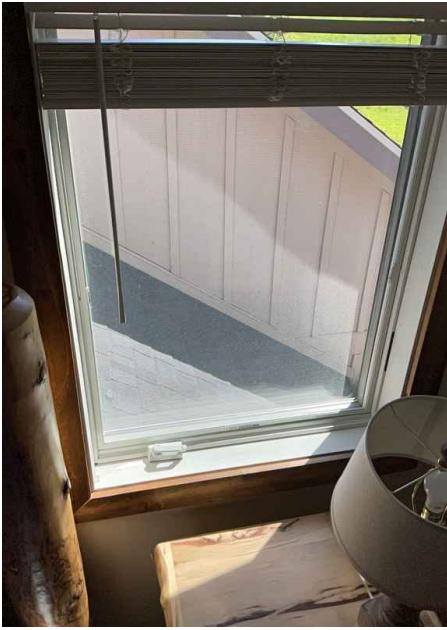
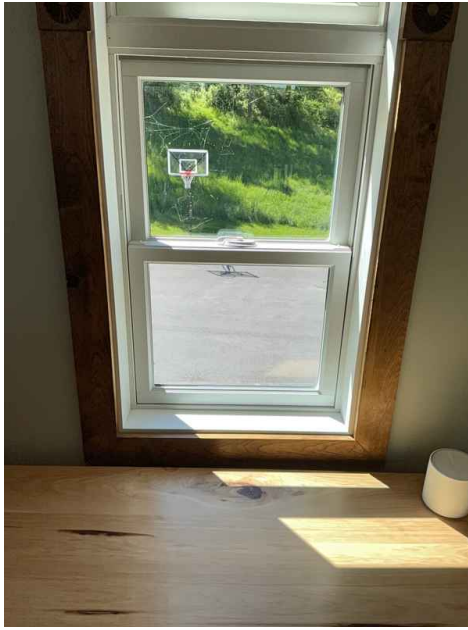
Locking lever mechanism was missing on the day of inspection.

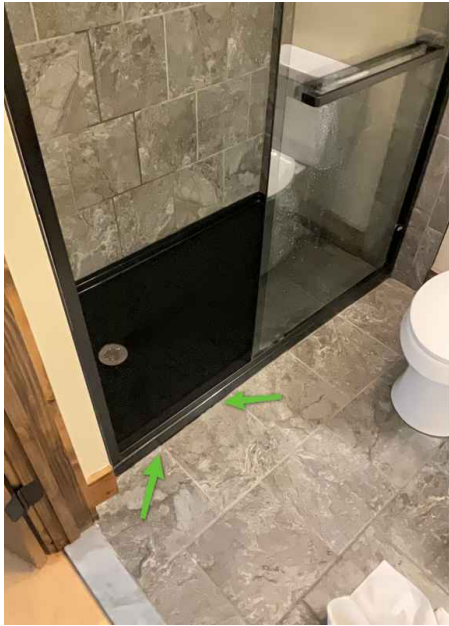
### Floors: Bathroom floor tile missing grout

2nd floor bathroom at the base of shower on the outside entry way.

Observed bathroom floor missing grout. This may lead to moisture intrusion, weakening of the substructures over time and possible mold.
