THOROUGHbred PROPERTY INSPECTIONS LLC

## RESIDENTIAL REPORT

SAMPLE ONLY

05/31/2026

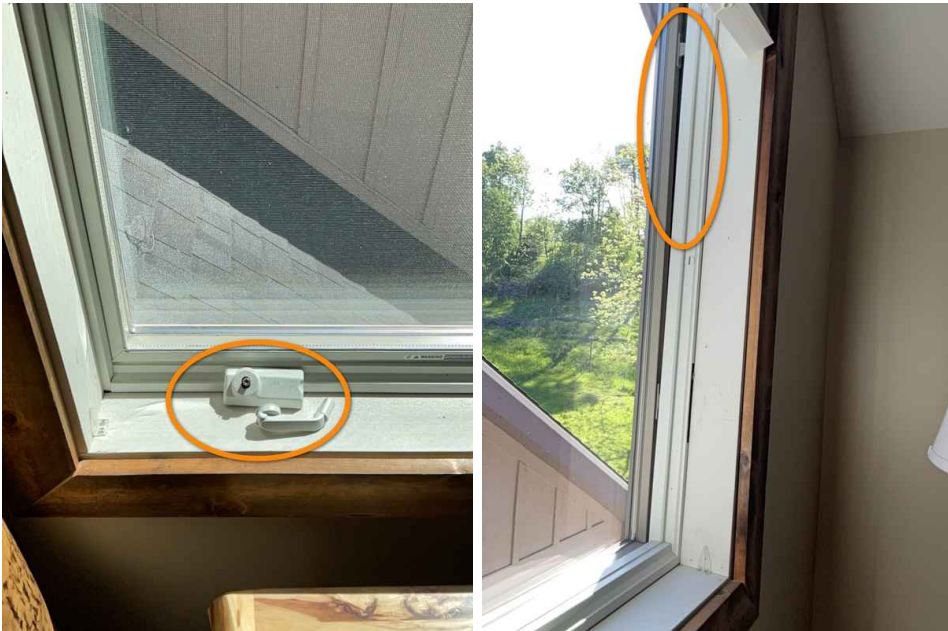
11.2.1 Windows

Upstairs bedroom window is not closing properly and the crank is not secured. Could potentially allow moisture intrusion. Recommend a window professional clean, lubricate & adjust as necessary.

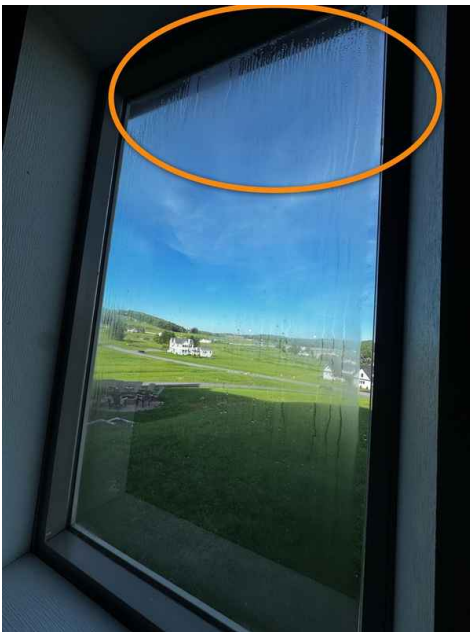
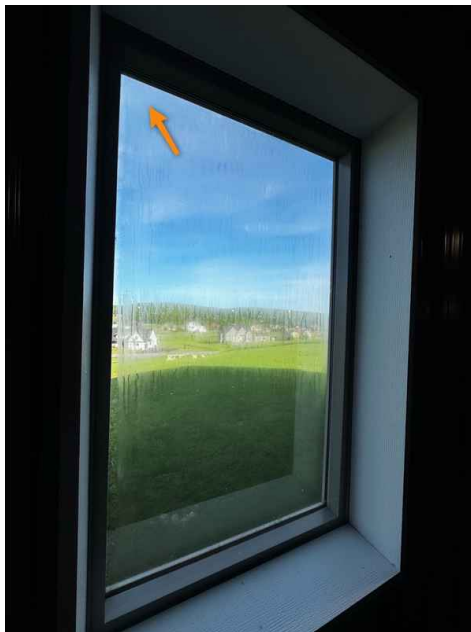
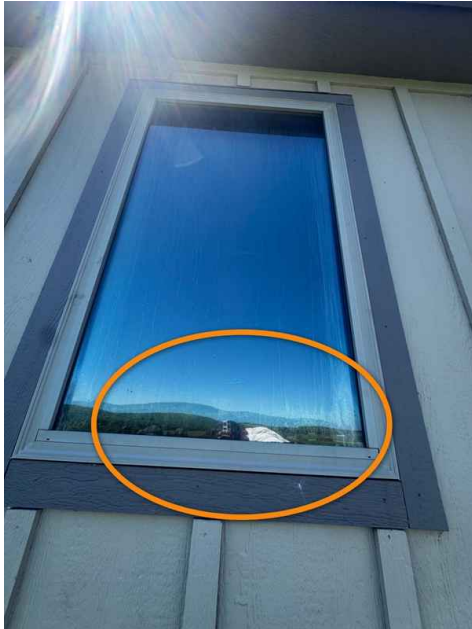
### 11.2.2 Windows

Observed condensation between the window panes in the pool room, which indicates a failed seal. Recommend qualified window contractor evaluate & replace.

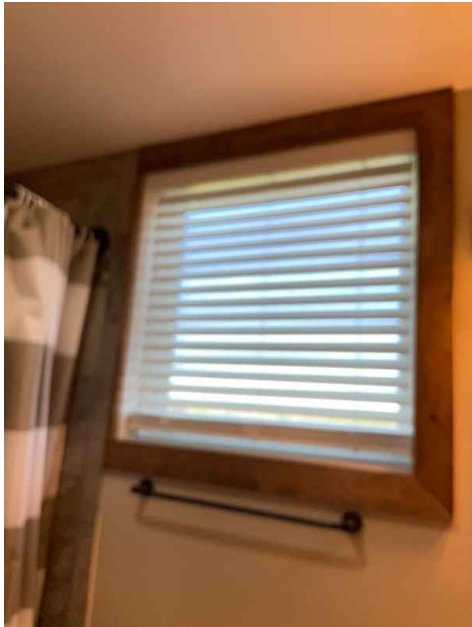
### 11.5.1 Ceilings

Thermal imaging detected a temperature difference at the upper wall/ceiling area & window trim. Follow-up moisture meter testing at the location produced elevated, moisture-like readings. Conditions may indicate moisture intrusion or condensation related moisture accumulation. Recommend further evaluation by a qualified contractor.

Contact a qualified professional.

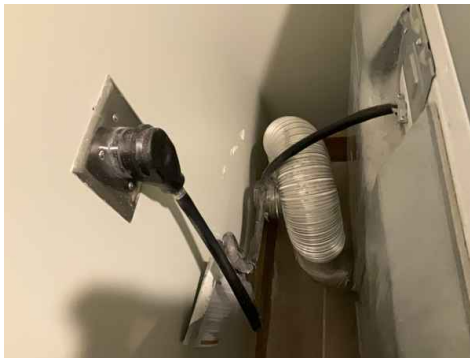
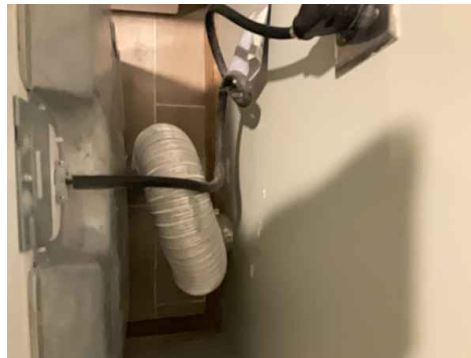
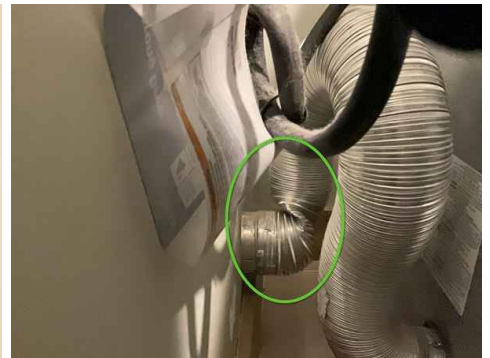
The dryer exhaust duct was observed to be crimped/kinked behind the dryer / at the wall connection.

A crimped duct restricts exhaust airflow, which promotes lint accumulation and elevated operating temperatures, a recognized fire hazard. Restricted dryer venting also reduces drying efficiency and can shorten appliance life.

Recommend the duct be corrected to allow unrestricted airflow, and that combustible vinyl/plastic transition duct, if present, be replaced with smooth rigid or UL-listed semi-rigid metal duct. Recommend the full duct run be cleaned of lint. Correction by a qualified contractor or the homeowner.

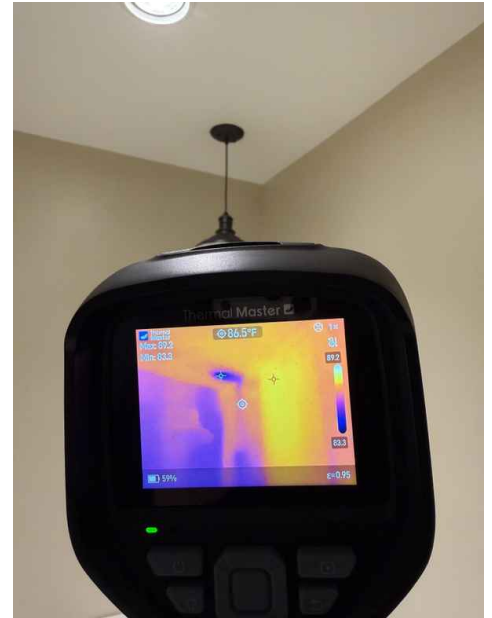
Pool room right upper part of ceiling showed a thermal differential. This may be caused by moisture intrusion, insulation displacement or air infiltration. This area is beneath the sagging pool room roof and may have moisture intrusion. A moisture meter detected a normal reading at the time of the inspection however moisture conditions can change with weather, season and roof/plumbing performance. Evaluation by a qualified contractor is recommended.

Contact a qualified general contractor.
